New Jersey Department of Environmental Protection Historic Preservation Office

PROPERTY REPORT Property ID:							
Property Name:	John Duncan House		Ownership:				
Address:	82 N Main ST		Apartment #: ZIP				
PROPERTY LOCATION(S):							
County:	Municipality:	Local Place Name:	USGS Quad:	Block: Lot:

Survey Name: Cranbury CLG Survey 2017 Surveyor: Kristen Herrick Organization: RGA, Inc.

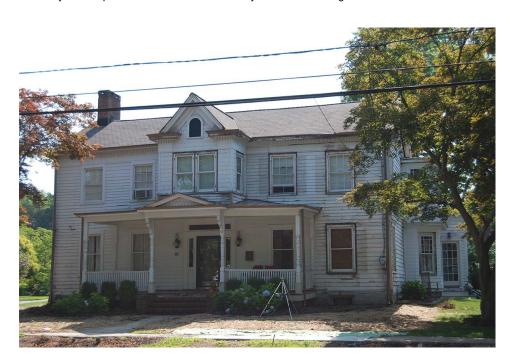
Property Photo:

The John Duncan House at 82 North Main Street is a two-and-a-half-story, five-bay, two-pile, frame private residence constructed circa 1825 and later remodeled with vernacular Greek Revival details. The house has a one-story full-length rear addition.

The side-gabled roof is sheathed with asphalt shingles. Rectangular interior brick chimneys are located near each end of the ridge. The molded cornice also runs around the centered cross-gable on the main elevation. A cross-gable over a protruding second floor bay has a molded raking cornice and cornice returns flanking a shuttered arched headed attic window. The bay is clad with shaped wood shingles and features a paired window unit of replacement one-over-one units on the main panel and a single window on the side panels. An expressed frieze with a dentil course runs along the wall surface below the eaves and also runs around the protruding bay. The exterior of the dwelling is clad in wood clapboard siding. Second floor windows are six-over-six units with wood sashes (possibly original); stains on the clapboards indicate that the windows formerly had shutters. The first floor has a door in the center bay (below the protruding second floor bay) and two one-over-one replacement windows in the outer bays. The door is a replacement unit with a large plate glass window and an exterior storm with a similar appearance, opening below a rectangular transom and between sidelights. The front porch extends along the center three bays. It has a hipped roof with an inset gable that extends slightly towards the road. The porch has a frieze and four turned columns connected by a low railing with turned balusters. The dwelling has a stone foundation with rectangular basement windows.
