New Jersey Department of Environmental Protection Historic Preservation Office

# PROPERTY REPORT

PROPERTY REPORT Property					701268132	
Property Name:	Uriah Dehart House			Ownersh	<b>nip:</b> Private	
Address:	60 N Main ST		Apartment #:	Z	<b>CIP:</b> 08512	
PROPERTY LOCATION(S):						
Country	Municipality	Local Diago Nama	LISCS Ound	Block	1.04

Survey Name: Cranbury CLG Survey 2017 Surveyor: Kristen Herrick Organization: RGA, Inc.

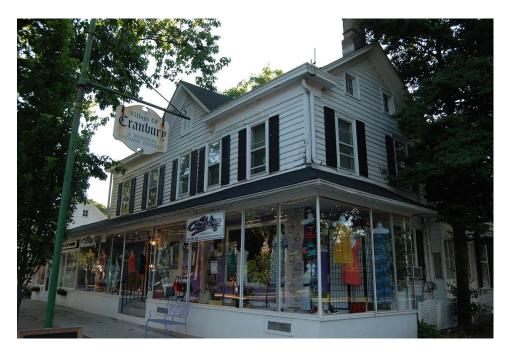
## **Property Photo:**

The Uriah Dehart House at 60 North Main Street is a two-and-a-half-story, five-bay, two-pile, frame commercial building and private residence constructed circa 1845 and later renovated in the Gothic Revival style. The building has multiple rear additions and a freestanding frame outbuilding to the east.

The main block is the two-and-a-half story, five-bay Gothic Revival commercial building. Its cross-gabled roof is sheathed with asphalt shingles and features a centered cross-gable with a rectangular window sealed with louvered shutters. The house has a molded cornice that doubles as an interior gutter system over an expressed wood frieze. The house has wood clapboard walls on the main elevation. The second floor has five one-over-one, double-hung, wood-sash (replacement) windows with aluminum storm windows and louvered shutters. A protruding storefront below a pent roof occupies the first floor; it features large plate glass windows and a recessed entrance with a metal crossbuck screen door accessed via two concrete steps.

The south end of the original building faces Park Place East. The south end chimney is clearly visible. The molded cornice has returns at the eaveline, flanking two four-light attic windows (possibly original). The storefront wraps around this elevation and occupies the western half of the elevation. Fenestration on the end wall is balanced, with one-over-one double hung sash windows flanked by louvered shutters, with two on the second floor and one on the first floor. The north end of the building shares many of the same features. The roof is clad
