PROPERTY REPORT

Property Name: 54 North Main Street **Ownership:** Private
Address: 54 N Main ST **Apartment #:** **ZIP:** 08512

Survey Name: Cranbury CLG Survey 2017

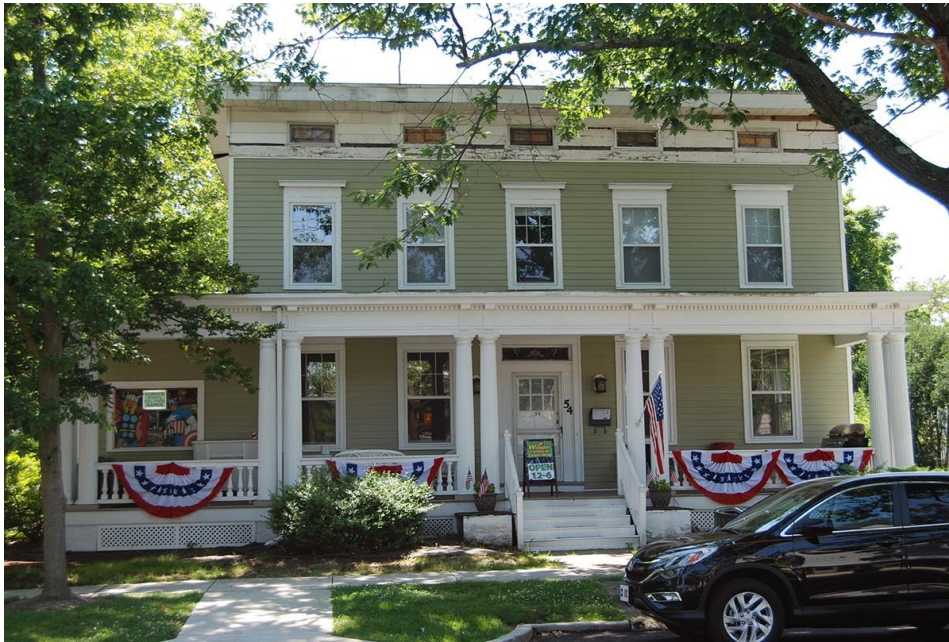
Property Photo:

54 North Main Street is a two-story tall, five-bay wide, three-bay deep, frame private residence constructed circa 1850 in a vernacular Italianate style. The dwelling consists of a square, hipped roof main block and a one-story, partially enclosed wraparound porch. The roof is sheathed with asphalt shingles. A frieze band of replacement windows runs beneath the overhanging eaves on all elevations. The exterior of the dwelling is clad in wood clapboard siding on the first floor and aluminum siding on the second floor of all elevations. Regular, symmetrical fenestration on the front elevation consists of six-over-one, vinyl-sash replacement windows with molded lintels. The enclosed portion of the porch has a large replacement picture window. The central historic entrance is a six-light, four-panel wood door topped by a rectangular transom in a molded surround. A one-story wraparound porch spans the width of the front elevation and is partially enclosed on the northeast elevation of the dwelling. The porch has a hipped roof, full classical frieze with dentils and triglyph/guttae pairs, paired fluted Doric column, and a railing with thick turned balusters. The northeast elevation has six-over-one, vinyl-sash replacement windows with molded wood lintels on the first and second floors. A six-light, fixed replacement window sits in the west bay on the first floor of the enclosed porch. A secondary entrance, a single door with a single pane above two vertical panels with a concrete stoop, is located in the east bay on the first floor of the enclosed porch. The southwest elevation has six-over-one, vinyl-sash replacement windows with molded wood lintels and a four-light hopper replacement window on the second floor. A semi-hexagonal projecting bay with six-over-one, vinyl-sash replacement windows is located in the west bay on the first floor. A secondary entrance, paired sliding doors with fifteen inset lights, is located in the east bay on the first floor. Character-defining elements of the dwelling include the one-story wraparound porch and

frieze band of windows. A one-story, front-gabled frame shed, constructed circa 1975, is located east of the dwelling.
