# PROPERTY REPORT

**Property Name:** John H. Covenhoven House

**Survey Name:** Cranbury CLG Survey 2017

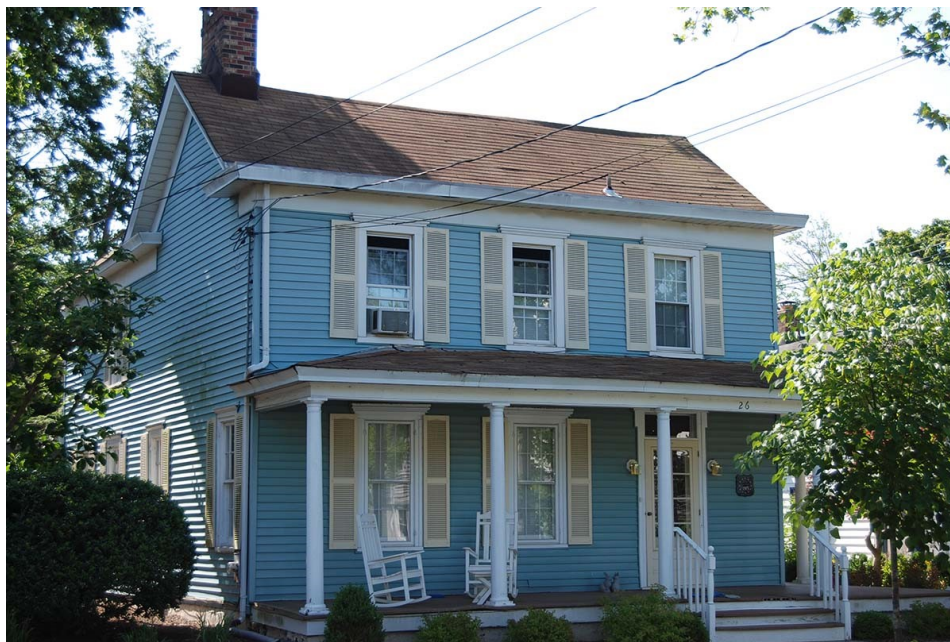
**Property Photo:**

The John H. Covenhoven House at 26 North Main Street is a two-story, three-bay, two-pile vernacular private residence constructed circa 1815. On the rear of the main block is a two-story rear addition with a slight T-shape and a one-story addition on the east elevation of the two-story addition.

The main block has a side-gabled roof sheathed with asphalt shingles. The molded cornice doubles as an interior gutter system (creating slightly flared eaves), and its soffits are clad with vinyl over an expressed frieze. A brick interior chimney pierces the roof near the north end of the ridge. The exterior of the dwelling is clad in vinyl siding. Fenestration on the main elevation is symmetrical. Windows are six-over-six double hung sash (possibly original), flanked by louvered shutters. The entrance consists of an eight-light, one-panel wood exterior door with a floral transom and an interior wood door that features two vertical plate glass panes and a filigree design. The entrance casing features a slight crosssette shape. The front porch extends along the west and south elevations. It has a hipped roof clad with asphalt shingles and supported by thin Doric columns. The porch has a wood floor and steps leading between simple railings to the grade of the sidewalk. The house has a stone foundation.

On the south end wall, the molded cornice features returns. The wall surface is clad with vinyl siding. The elevation has a double hung sash attic window (appears to be replacement) and a first floor window facing onto the wrap-around porch.

On the north elevation, the brick chimney is visible above the molded cornice with its returns. The frame wall surface is clad with vinyl siding. The wall surface is mostly solid, with the only openings being double hung sash units that appear to be replacement (with louvered shutters).

Character-defining elements of the dwelling include a one-story wraparound porch with Doric columns and six-over-six, double-hung, wood-sash windows (potentially original) with molded lintels below a wood frieze on the front (northwest) elevation.

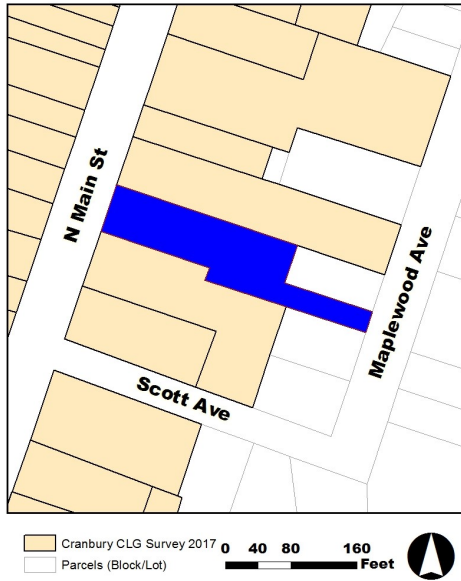
**Site Map:**

The John H. Covenhoven House at 26 North Main Street is sited on a rectangular parcel (Block 32, Lot 11) located on the west side of North Main Street in Cranbury Township, Middlesex County, New Jersey. The dwelling is oriented with its primary elevation facing northwest and is set back approximately 10 feet from North Main Street. A concrete sidewalk, which runs along North Main Street, spans the west side of the parcel. Perennial plantings about the dwelling's front (northwest) elevation. Shrubs line the north side of the parcel. The property is lightly wooded. 26 North Main Street is located in a mixed residential and commercial neighborhood surrounded by properties dating from the mid-nineteenth to the early twentieth century.
