PROPERTY REPORT

Property Name: 5 Maplewood Avenue
Address: 5 MAPLEWOOD AVE

Survey Name: Cranbury Local Historic District Survey 2018

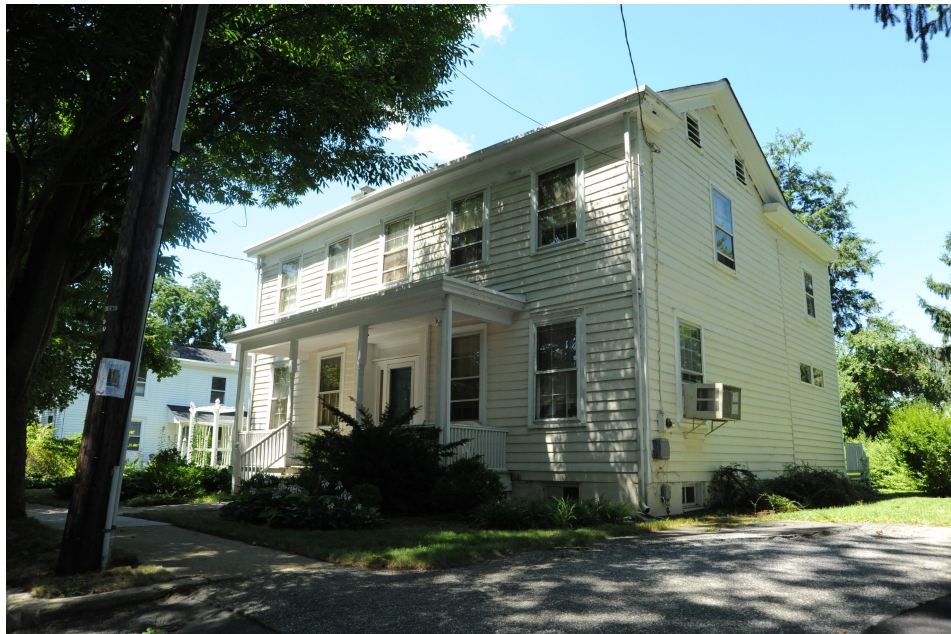
Property Photo:

The 2 1/2-story, rectangular-plan, gable-roofed, clapboard-clad main volume on a parged foundation of this frame residence is 6 bays wide and 3 bays deep and is backed on the northwest by a partial-width, 2-story, composite-roofed, 5-bay wide and 1-bay deep rear volume, which is backed in turn by a 1-story, partial-width, shed-roofed rear el. A 1-story, composite-roofed, partial-width, centered porch projects from the southeast, main elevation, and a 1-story, hip-roofed porch flanks the rear volume on the southwest, side elevation. An interior, stuccoed chimney projects from the southwest bay of the gable ridge. Excluding the composite roofs, the roofs throughout are clad in asphalt shingle. The windows predominantly have 6/6, historic wood sash. The wood porch on the southeast, main elevation is accessed by a straight concrete stair and includes replaced, square plan outer posts, historic turned posts flanking the central stair, and a handrail with square-plan banisters. The house is primarily accessed through a historic door in the central bay of the main elevation. The entrance includes historic sidelights and a covered transom. Each of the remaining bays contains a window on both floors. The northeast, side elevation includes a window in the southeastern bay of the first floor and a central window on the second floor. The rear volume includes a replaced, double, fixed window on the first floor and a window on the second floor. The northwest, rear elevation is only partially visible from the public right-of-way and includes an added window bay on the second floor and a single window in the south bay of the second

floor. Two added skylights light the rear el. The southwest, side elevation includes a window in each of the outer bays except the west bay of the second floor. Both side elevations include 2 louvered vents under the gable peak. A single window lights the southwest side of the second floor of the rear volume. A secondary entrance, not visible from the public right-of-way, is accessed by the side porch.

This property is a contributing property in the historic district because it retains integrity and historic character-defining features such as its historic massing and fenestration patterns, historic wood clapboard cladding, historic wood windows and doorway, and historic porch details.
