PROPERTY REPORT

Property Name: 7 Maplewood Avenue
Address: 7 MAPLEWOOD AVE

Survey Name: Cranbury Local Historic District Survey 2018

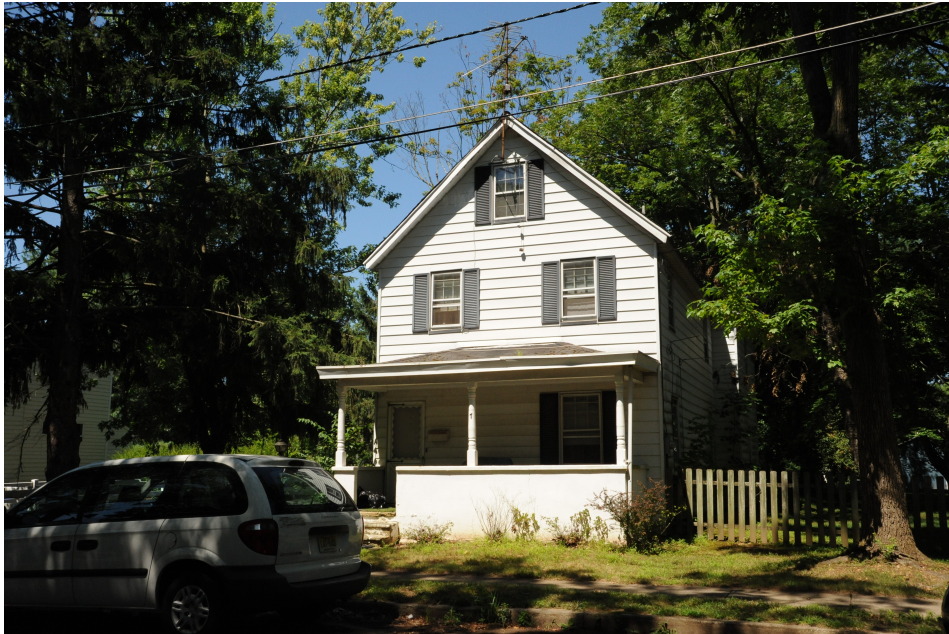
Property Photo:

The 2 1/2-story, rectangular-plan, gable-roofed, aluminum siding-clad, main volume of this frame residence on a parged foundation is 2 bays wide and 3 bays deep. The main volume is fronted on the southeast by a 1-story, hip-roofed, full-width front porch with added, stuccoed knee walls and historic, turned posts, and flanked on the southwest elevation by a partially enclosed, 1-story, hip-roofed side porch. The main volume is backed on the northwest by a partial-width, 2-story, composite-roofed rear volume on the northeast and a 1-story, hip-roofed rear volume to its southwest. The roofs are clad in asphalt shingle and the windows predominantly contain historic 6/6 wood sash. An interior brick chimney projects from the central bay of the gable ridge. The primary entrance to the residence is in the southwest bay of the main elevation, with a window in each of the remaining bays on both floors. A single window lights the third floor. The north, side elevation includes a window on each floor of the outer bays, with a window on each floor of the rear volume. The west, rear elevation is only partially visible from the public right-of-way and includes a window in the south bay of the second floor and a single window on the third floor. The 1-story, hipped roof porch projects from the west bay of the south, side elevation and includes an enclosure with aluminum windows to the west and a secondary door to the east. Each of the remaining bays includes a window. The 1-story volume to the rear includes an additional door and double window on the south, side elevation, with a single window in the 2-story volume.
