PROPERTY REPORT

Property Name: 19 Maplewood Avenue **Ownership:** Private
Address: 19 MAPLEWOOD AVE **Apartment #:** **ZIP:** 08512

Survey Name: Cranbury Local Historic District Survey 2018

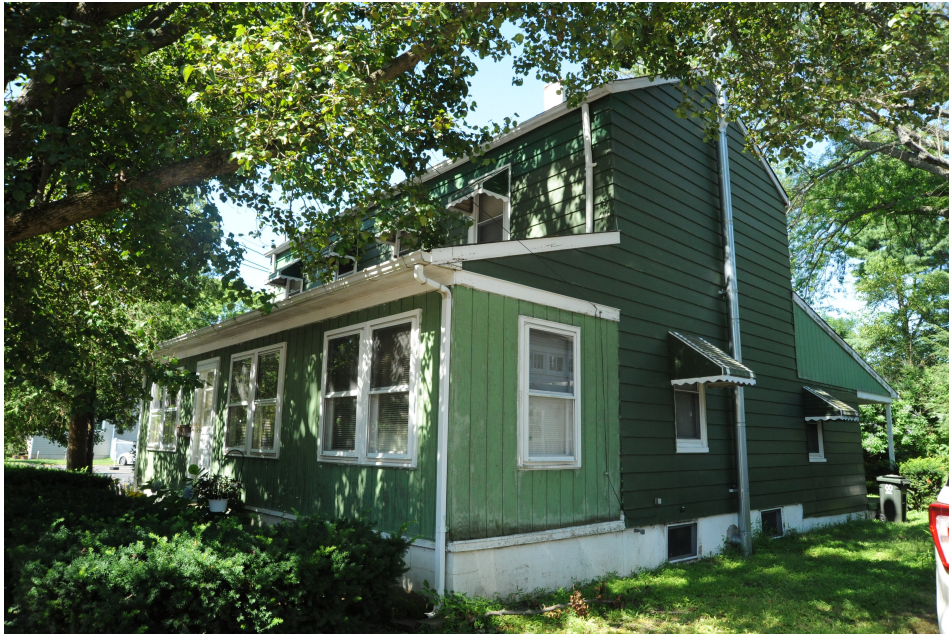
Property Photo:

The main block of the 2-story, gable-roofed, rectangular plan, clapboard-clad, frame dwelling on a parged foundation is 4-bays wide and 2-bays deep and is fronted on the southeast by a 1-story, full-width, shed-roofed, enclosed porch and backed by a 2-story, partial-width, shed-roofed volume to the southwest and a 1-story, shed-roofed rear el and porch on the northeast. The roofs are predominantly clad in asphalt shingle. The windows have been replaced throughout and predominantly have 1/1 sash with aluminum awnings. An interior stuccoed chimney projects from the north, central bay of the gable ridge. The plywood-clad, enclosed front porch on the southeast, main elevation is accessed by a historic paneled door in the central bay with paired windows in the flanking bays. The porch is lighted on either side by a single window. The second floor of the southeast elevation is lighted by a window in each bay. The northeast, side elevation is lighted by a window in the east bay of the first floor of the main volume and a window in the rear el. The northwest, rear elevation is not visible from the public right-of-way. The southwest, side elevation is lighted by a single window on the second floor of the rear volume.

This property is a non-contributing property in the historic district by virtue of the building's loss of integrity from extensive alterations in the period after the 1970s, in which all historic exterior materials were replaced and the historic open front porch was enclosed.
