PROPERTY REPORT

Property Name: 21 Maplewood Avenue **Ownership:** Private
Address: 21 MAPLEWOOD AVE **Apartment #:** **ZIP:** 08512

PS&S recommends that the residence at 21 Maplewood Avenue, constructed between 1850 and 1876, is a contributing property in the Cranbury Historic District.

Survey Name: Cranbury Local Historic District Survey 2018

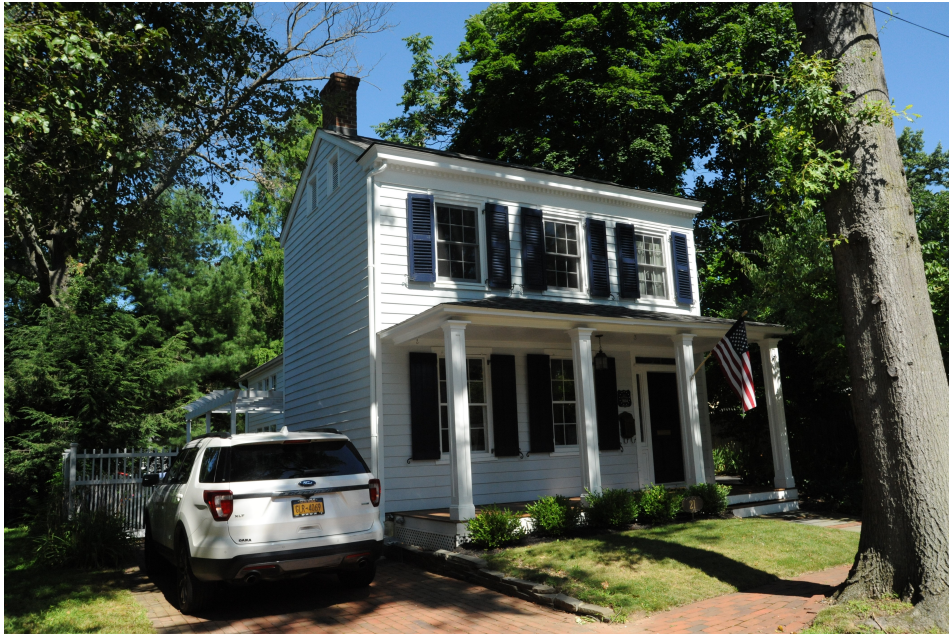
Property Photo:

The 2-story, gable-roofed, rectangular plan, replacement clapboard-clad, main block on a parged foundation of this frame dwelling is 3 bays wide and 2 bays deep and is fronted on the southeast by a 1-story, full-width, hip-roofed porch and backed on the northwest by a 2-story, 3-bay deep, partial-width secondary volume offset to the northeast. The roofs throughout are clad in asphalt shingle and the windows predominantly have replacement 6/6 wood sash. An interior, ridge, brick chimney is located near the southwestern end of the main block, and 2 interior, ridge, brick chimneys are located on the rear volume. The front porch includes replacement, square-plan posts and provides access to the primary entrance in the northwestern bay, which includes a historic door surround. Single windows with replacement wood shutters are located in each of the remaining bays on both floors. The roofline of the southeast elevation includes added dentils. The northeast, side elevation is lighted in the rear volume by a 6/6 window on the first floor and a single and triple casement window on the second floor. The northwest, rear elevation is not visible from the public right-of-way. The southwest, side elevation is only partially visible from the public right-of-way and includes a triple window in the east bay of both floors, a secondary door on the first floor of the central bay with a bank of 2/2 slider windows on the second floor.
