New Jersey Department of Environmental Protection Historic Preservation Office

# **PROPERTY REPORT**

· · · · · · · · · · · · · · · · · · ·			
Property Name:	50 North Main Street	Owner	ship:	Private	
Address:	50 N Main ST	Apartment #:	ZIP:	08512	
PROPERTY LOCA	ATION(S):

Survey Name:
 Cranbury CLG Survey 2017

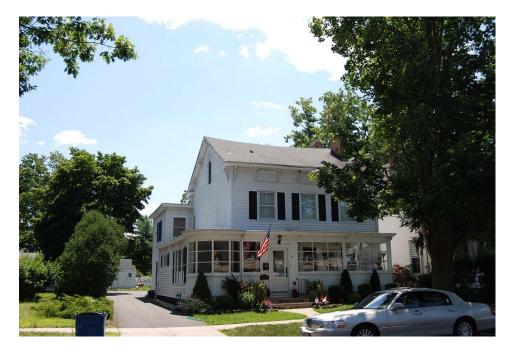
## **Property Photo:**

50 North Main Street is a two-story tall, three-bay wide, three-bay deep, frame private residence constructed circa 1870 with Italianate details. The dwelling consists of a two-story, side-gabled main block; a two-story, two-bay rear addition; and a one-story enclosed wraparound porch. The roof is sheathed with asphalt shingles. Two brick interior chimneys are located at the southwest gable end of the main block, one on either bent of the roof. The dwelling's molded wood cornice is supported by brackets with a return cornice at the gable ends. Brackets on the front elevation frame three rectangular molded wood panels. The exterior of the dwelling is clad in vinyl siding on all elevations. Windows on the front elevation are two-over-one, double-hung, replacement wood-sash windows with inoperable louvered shutters. The first floor is obscured by a wraparound porch later enclosed with windows and clad in aluminum siding. The northwest corner of the porch is rounded. On the northwest elevation, a six-over-six vinyl-sash replacement window, set within an earlier arched surround, sits in the gable end of the main block. Windows on the second floor are one-over-one, vinyl-sash replacement with inoperable louvered shutters on the rear addition only. On the first floor, the enclosed porch has two sets of triple one-over-one, double-hung, wood-sash windows with inoperable louvered shutters. The rear addition has paired vinyl replacement casement windows with inoperable louvered shutters in the upper sash. The rear addition has paired vinyl replacement casement windows with inoperable louvered shutters in the public right of way. The southwest elevation features a six-over-six vinyl-sash replacement wood-sash windows on the first and second floors. The bracketed cornice with molded wood panels on the front elevation is a character-defining

element of the dwelling. A one-story, side-gabled frame shed (built circa 2015) is located to the rear of the dwelling.

The 1989 Heritage Studies survey identified 50 North Main Street as a contributing resource to the Cranbury Historic District. RGA concurs with the previous evaluation and recommends 50 North Main Street as a contributing resource due to its date of construction and design.
