PROPERTY REPORT

Property Name: 6 Park Place
Address: 6 PARK PL E
Ownership: Private
Apartment #:
ZIP: 08512

PS&S recommends that 6 Park Place East, which includes a house constructed circa 1870 and a garage built circa 1920-25, is a contributing property in the Cranbury Historic District.

Survey Name: Cranbury Local Historic District Survey 2018

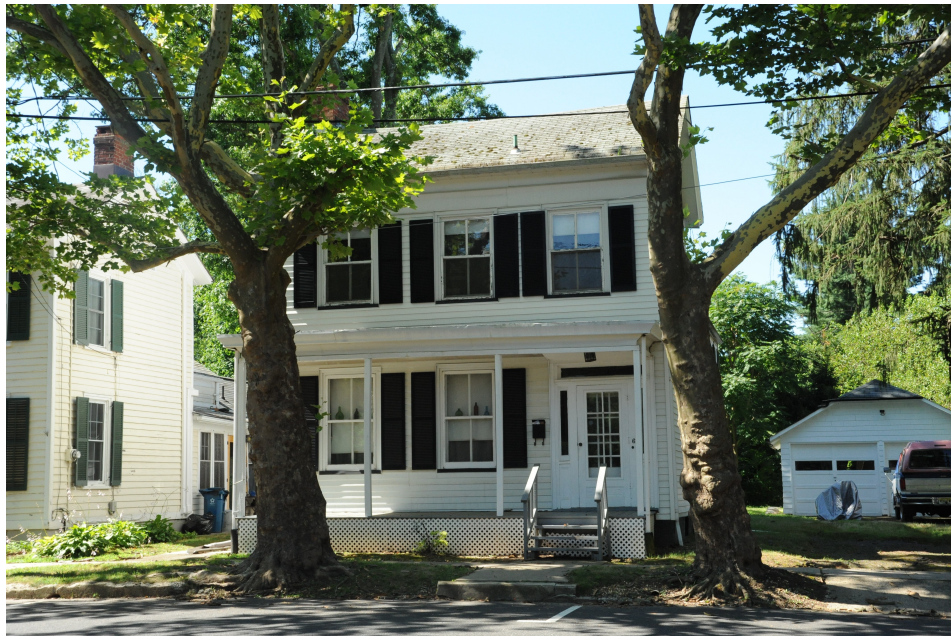
Property Photo:

The 2-story, side gable-roofed, rectangular-plan main block of this vinyl-siding clad, frame dwelling on a brick foundation is 3 bays wide and 2 bays deep and is fronted on the northeast by a 1-story, full-width porch and backed on the southwest elevation by a 2-story, partial-width rear volume offset to the northwest bays. The rear volume is flanked on the northeast side by a 1-story, shed-roofed, historically enclosed side porch that connects to a 1-story rear el that wraps 1 bay around the south corner of the building. The roofs are predominantly clad in asphalt shingle and the windows predominantly have 2/2 historic wood sash with applied shutters. An interior, ridge, brick chimney is located on the southeast end of the main roof. The front porch, accessed by a straight stair in the northwest bay, includes simple square-plan posts. The primary entrance to the residence, located in the northwest bay of the northeast elevation, includes a historic 8-light storm door, a historic replacement 9-light door, and a historic door surround with single-light sidelights over recessed panels and a single light transom. The remaining bays of both floors are regularly fenestrated. The main block is lighted on the northwest, side elevation by a small window under the gable. The rear volume is regularly fenestrated. The southeast, side elevation is lighted in the main block by a single window on the first floor and 2 casement windows under the gable, 1 of which is has historic, 4-light sash. The 1-story historically enclosed side porch volume is accessed by a historic 4-light door with a historic, 8-light wood storm door flanked on each

side by paired 6/6 historic wood sash windows. The southeasternmost bay, historically part of the wrapping rear el, retains a paired, 2/2 window. The southwest, rear elevation is not visible from the public right-of-way.

A 1-story, jerkinhead-roofed, 2-bay, clapboard and painted wood shingle-clad, frame garage is located to the southwest of the residence and includes 2 historic, 2-light, roll-up garage doors.

6 Park Place East is a contributing property in the Cranbury Historic District because it retains integrity and historic, character-defining features such as its historic massing and fenestration patterns, historic window sash reflecting 2 construction periods, historic replacement doors, historic storm doors, and historic chimney. The garage retains its historic volume, exposed roof rafter tails, and historic cladding.
