PROPERTY REPORT

Property Name: William Silvers House **Ownership:** Private
Address: 46 N Main ST **Apartment #:** **ZIP:** 08512

Survey Name: Cranbury CLG Survey 2017

Organization: RGA, Inc.

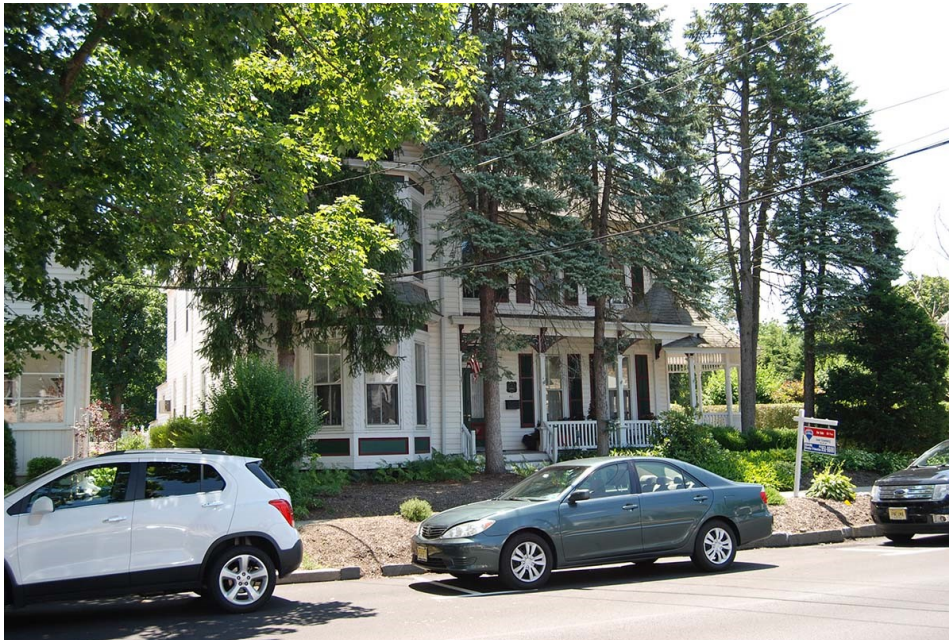
Property Photo:

The William Silvers House at 46 North Main Street is a two-story tall, three-bay wide, two-bay deep, frame private residence constructed circa 1881 in a Queen Anne style. The dwelling consists of a front gable-and-wing main block; two-story, two-bay rear additions to the southeast (built circa 1910) and southwest (built circa 1978); a one-story, two-bay hipped roof addition adjoining the rear additions (built circa 1978); and a one-story, one-bay shed roof addition adjoining the southeast rear addition (built circa 1910). The dwelling also has a three-bay enclosed porch on the southwest elevation. The roof is sheathed with asphalt shingles. Three interior brick chimneys pierce the roof: one on the northeast bent of the front-gabled portion, one on the southeast bent of the wing, and one at the southeast gable end of the southeast rear addition. The exterior of the dwelling is clad in wood clapboard siding on the front elevation and vinyl siding on all other elevations. On the front elevation, a two-story, semi-hexagonal projecting bay with flared eaves and rectangular, molded panels is located in the north bay. The projecting bay is clad in wood fish scale shingles. All windows on the front elevation are two-over-two, double-hung, wood-sash windows with aluminum storm windows and painted louvered shutters on the wing. The entrance, located south of the projecting bay, is a double-leaf, single-light wood door with molded square panels, topped by a stained glass transom in a molded wood surround. The first floor of the wing is sheltered by a porch with square and turned wood posts, a low railing with turned balusters, decorative filigree brackets, and a turret roof at the rounded southwest corner. The southwest elevation has a two-story, semi-hexagonal projecting bay with flared eaves and rectangular, molded panels, clad in wood fish scale shingles, on the wing. Windows on the southwest elevation, including the projecting bay are two-over-two, double-hung, wood-sash, with painted louvered shutters on the second floor of the

southwest rear addition. The first floor of the southwest rear addition is sheltered by a shed roof (covered with standing seam metal) enclosed porch with aluminum screen windows below a frieze of rectangular fixed vinyl windows with an inlaid floral design. The rear elevation is not visible from the public right-of-way. Windows on the northeast elevation are two-over-two, double-hung, wood-sash windows on the main block and southeast rear addition. Character-defining elements of the dwelling include the two-story semi-hexagonal projecting bays with wood fish scale shingles, the one-story front porch with corner turret, and wood-sash windows with louvered shutters. Three frame outbuildings (built circa 1881) are located at the rear of the property: two one-story, front-gabled frame sheds and a two-story, side-gabled frame barn.

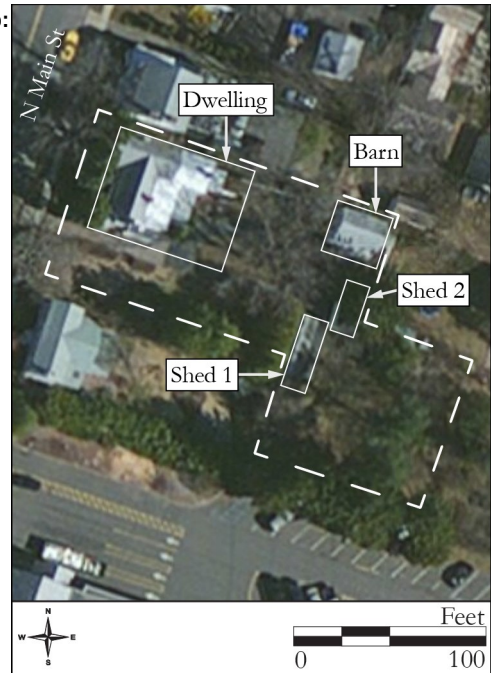
Site Map:

The William Silvers House at 46 North Main Street is sited on an L-shaped parcel (Block 32, Lot 3) located on the east side of North Main Street in Cranbury Township, Middlesex County, New Jersey. The dwelling is oriented with its primary elevation facing northwest and is set back approximately 15 feet from North Main Street. A concrete sidewalk, which runs along North Main Street, spans the west side of the parcel. A stone driveway leads east from North Main Street past the southwest elevation of the dwelling to a paved, circular driveway at the rear (east) of the dwelling. Three frame outbuildings are located east of the dwelling. The property is lightly wooded, with mature conifers and perennial plantings adjoining the front (northwest) elevation. 46 North Main Street is located in a mixed residential and commercial neighborhood surrounded by properties dating from the mid-nineteenth to the early twentieth century.
