PROPERTY REPORT

Property Name: First National Bank of Cranbury

Address: 32 N Main ST

Survey Name: Cranbury CLG Survey 2017

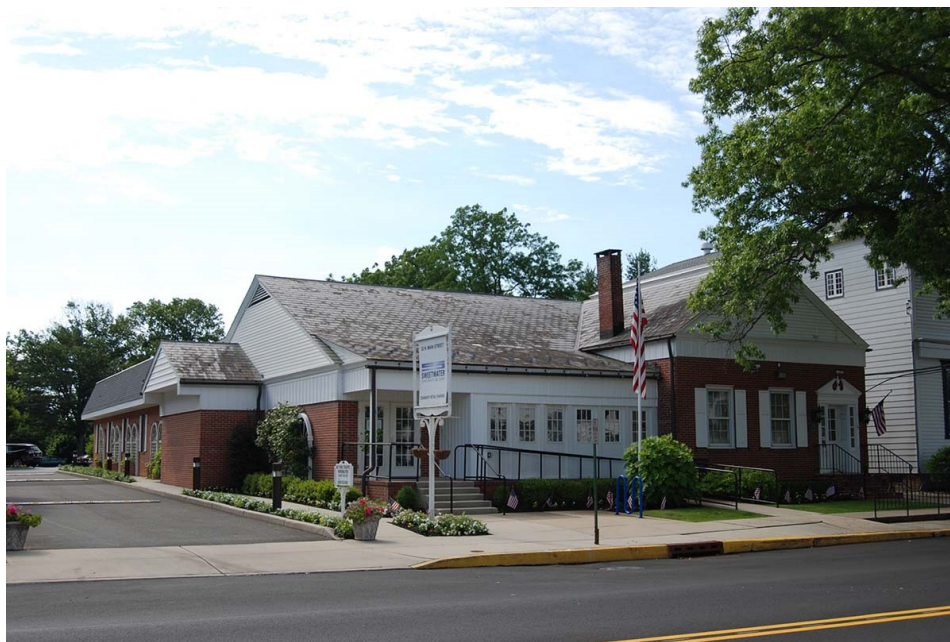
Property Photo:

First National Bank of Cranbury at 32 North Main Street is a one-story tall, three-bay wide, five-bay deep, brick commercial building constructed circa 1884 and extensively renovated in 1953 with Colonial Revival details. The building has multiple additions: a one-story, three-bay wide addition and a two-story, four-bay wide, side-gabled addition on the rear (built circa 1953); a one-story tall, seven-bay wide, side-gabled addition to the northeast (built circa 1976); and a one-story, five-bay wide, hipped roof addition to the northeast (built circa 1984). The roof is clad in slate shingles on the main block and circa 1976 addition, with asphalt shingles on the circa 1953 and circa 1984 additions. An interior brick chimney pierces the roof on the northeast slope of the main block. The exterior of the building is faced with brick on all elevations with vinyl siding in the gable ends and faux board and batten siding on the front elevation of the circa 1976 addition. A faux board and batten frieze runs beneath the eaves on the front and side elevations. A clock perforates the the front gable end of the main block. The front elevation of the main block has two six-over-six, double-hung, replacement wood-sash windows with aluminum storm windows, flanked by inoperable paneled shutters. The 1976 addition has nine-light fixed vinyl windows arranged in a row and separated by simple square pilasters. A bronze deposit box is located in the northwest corner of the main block, below one of the windows. The entrance to the main block, located in the south bay, is a single nine-light, two panel wood door with segmented sidelights above rectangular panels. A broken pediment featuring a carved urn tops the door. This entrance is accessed by a brick stoop with wrought iron railings. Another entrance, two single doors with fifteen inset lights each, is located in the north bay on the 1976 addition. This entrance is recessed and accessed by a concrete stoop and ramp with metal railings.

The northeast elevation features a projecting bay with a front-gabled roof and a faux board and batten frieze. This projecting bay, void of any openings, is a remnant of a drive-up service window that was added to the building circa 1953 and removed circa 2014. Windows on the northeast elevation are nine-over-nine, vinyl-sash windows with inoperable paneled shutters on the circa 1953 and circa 1984 additions. The southwest elevation also has nine-over-nine, vinyl-sash windows on the main block and the circa 1953 rear additions. A metal box with a rounded top, labeled "security alarm," is located in the west corner of the elevation, above one of the windows.
