PROPERTY REPORT

Property Name: 48 Maplewood Avenue

Survey Name: Cranbury Local Historic District Survey 2018

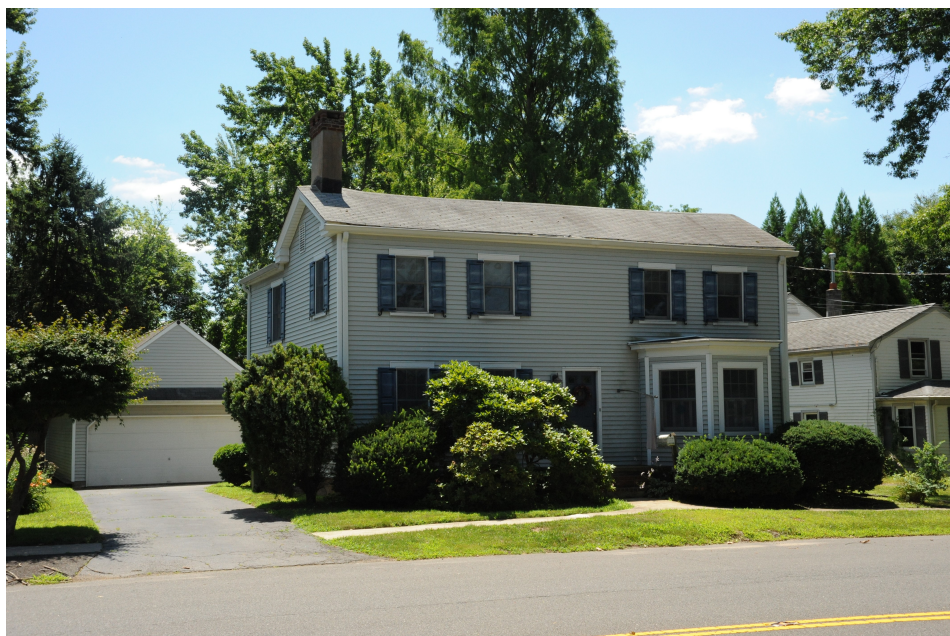
Property Photo:

PS&S recommends that 48 Maplewood Avenue, constructed between 1850 and 1876 and extensively altered, is a non-contributing property in the Cranbury Historic District.

The 2-story, gable-roofed, rectangular-plan, main block of this vinyl siding-clad, frame residence on a parged foundation is 5 bays wide and 2 bays deep and is fronted in the southwestern bay of the northwest elevation by a 1-story, composite-roofed, 3-sided projecting bay and backed on the southeast by a 2-story, gable-roofed, altered rear volume in 2 sections. The roofs are predominantly clad in asphalt shingle and the windows have 6/1 replacement sash with replacement shutters. A substantial, brick, interior, ridge chimney projects from the northeast bay of the main volume. The primary entrance, located in the central bay of the northwest, main elevation, includes a replaced metal door. The projecting front bay, is lighted by 3, 8/1 replacement windows. Each of the remaining bays of both floors are lighted by a single window. The southwest, side elevation is lighted by a single window on the second floor of the main block and 2 fixed windows in the rear el. The southeast, rear elevation is not visible from the public right-of-way. The northeast, side elevation is lighted by a single window on each floor of the main block and of the rear volume.

This property is a non-contributing property in the historic district by virtue of the building's loss of integrity from extensive alterations in multiple periods, in which all historic exterior materials were replaced, historic chimneys removed, and the historic massing of the building was altered by a substantial addition that is partially visible from the public right-of-way.
