PROPERTY REPORT

Property Name: 46 Maplewood Avenue **Ownership:** Private
Address: 46 MAPLEWOOD AVE **Apartment #:** **ZIP:** 08512

PS&S recommends that 46 Maplewood Avenue, perhaps constructed as early as the late 18th century and substantially altered in the late 20th century, is a non-contributing property in the Cranbury Historic District.

Survey Name: Cranbury Local Historic District Survey 2018

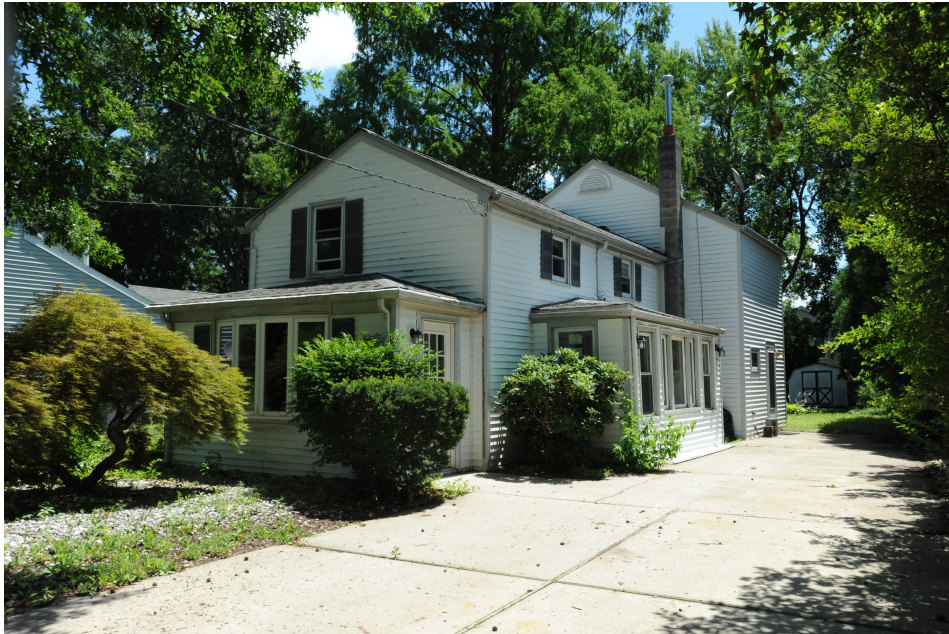
Property Photo:

The 2-story, gable-roofed, rectangular plan, main block on a covered foundation of this aluminum siding-clad, frame residence is 2 bays wide and 4 bays deep and is fronted on the northwest by a 1-story, hip-roofed volume and backed by a large, 2 1/2-story, gable-roofed addition. An enclosed, partial-width, 1-story, hip-roofed porch is located on the southwest side of the main volume. The roofs throughout are clad in asphalt shingle and the windows predominantly have replaced 1/1 vinyl sash with applied shutters. An exterior, added, concrete block chimney projects from the southwest bay of the northwest elevation of the rear volume. The northwest, main elevation is lighted by a 4-light bay window on the first floor of the 1-story volume and a single window in the northeast bay of the second floor of the main block. The primary entrance to the residence is located on the southwest elevation of the 1-story volume. The southwest, side elevation is lighted by a 3-light central window in the additional volume with a single window on each side. The second floor is lighted by 2 windows. The addition includes a secondary entrance in the central bay and a small fixed window on the first floor. The southeast, rear elevation is not visible from the public right-of-way. The northeast, side elevation is lighted by a window in the front volume and 2 windows on each floor of the main block. The addition is lighted by a single casement window on the first floor.

This property is a non-contributing property in the historic district by virtue of the building's loss of integrity from extensive alterations, in which all historic exterior materials were replaced and the historic massing of the building was significantly altered by an overscaled addition. While some portion of this building may retain 18th-century fabric, there is no visible evidence on the exterior that this is the case.
