PROPERTY REPORT

Property Name: 44 Maplewood Avenue **Ownership:** Private
Address: 44 MAPLEWOOD AVE **Apartment #:** **ZIP:** 08512

Survey Name: Cranbury Local Historic District Survey 2018

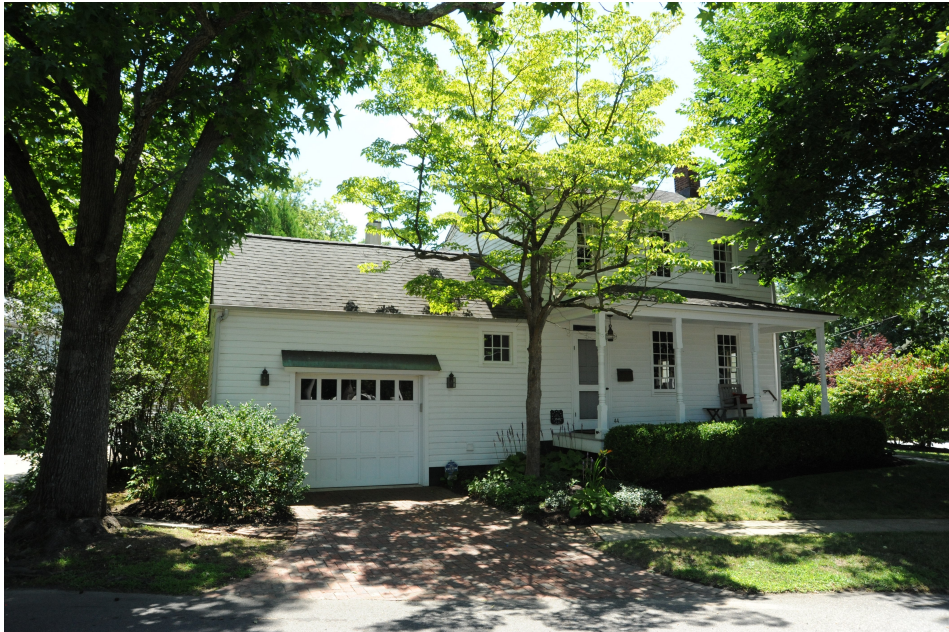
Property Photo:

The 2-story, gable-roofed, rectangular-plan, clap-board clad, frame, historic main block on a parged foundation of this residence is 3 bays wide and 2 bays deep and is fronted on the northwest by a 1-story, hip-roofed, full-width porch. Added and altered 1- and 2-story, gable-roofed rear volumes form an H-plan, with a projecting, 1-story, flat-roofed porch topped with a deck centered on the southwest, side elevation. A 1-story, gable-roofed garage flanks the main volume on the northeast. The roofs are predominantly clad in asphalt shingle and the windows in the main volume retain historic, double-hung wood sash. An interior, brick, ridge chimney is located near the southwest end of the main volume. The front porch includes historic turned wood posts. The primary entrance is located in the northeast bay and includes a paneled wood door that may be historic. The remaining bays of the first floor are both lighted by 9/6 windows, with 6/6 on the second floor. A fixed, 6-light, added window lights the garage volume and the garage is accessed by an added, roll-up door with top lights. The southwest, side elevation is lighted by a single window in each bay of the main volume. The secondary volume is lighted by a window in each bay with a fixed 4-light window under the gable end. The east, rear and north, side elevations are not visible from the public right-of-way.

This property is a contributing property in the historic district because it retains integrity and historic character-defining features such as its historic massing and fenestration patterns of the main volume, historic wood clapboard cladding, historic wood windows, and historic porch details. The scale and visibility of the rear additions from the public right-of-way make this status marginal.
