## PROPERTY REPORT

**Property Name:** 24 Maplewood Avenue  
**Address:** 24 MAPLEWOOD AVE

**Survey Name:** Cranbury Local Historic District Survey 2018

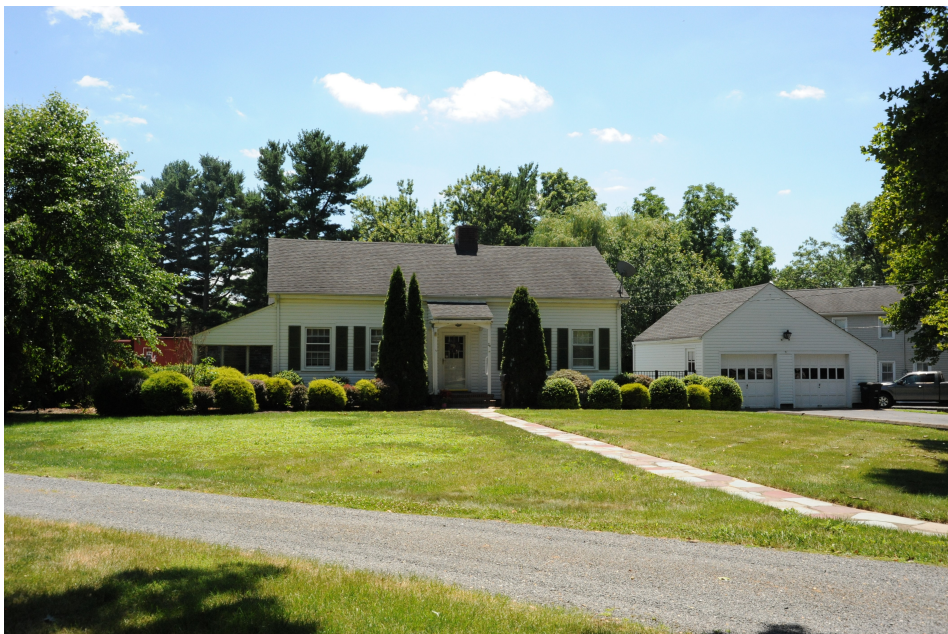
### Property Photo:

The 1 ½-story, gable-roofed vinyl, siding-clad, rectangular-plan main block of this frame Colonial Revival-style dwelling on a concrete foundation is 5 bays wide and 2 bays deep and is fronted on the northwest by a 1-story, 1 bay-wide, centered shed-roofed porch on square-plan posts with segmental arch openings. A 1-story, shed-roofed, enclosed porch is on the northeast, side elevation. The roofs throughout are clad in asphalt shingle and the windows predominantly have 8/12, double-hung, historic wood sash. An interior, ridge, brick chimney is located just southwest of the center of the main volume. The primary entrance, centered on the main elevation, is accessed via the porch and includes a replaced door. Each of the remaining bays includes a window with applied vinyl shutters. The southwest elevation of the enclosed porch is lighted by a bank of jalousie windows. The southeast, side elevation is lighted by 2 windows on the first floor and a single window on the second floor. The northeast, rear elevation is lighted by a single window in each bay but the central bay, with a triple window in the second floor dormer. The northwest, side elevation, only partially visible from the public right-of-way, includes a secondary entrance and is lighted by jalousie windows in the west bay.

This property is a contributing property in the historic district because it retains historic character-defining features such as its historic massing and fenestration patterns, historic windows and entrance porch.
