PROPERTY REPORT

Property Name: 24 Maplewood Avenue **Ownership:** Private
Address: 24 MAPLEWOOD AVE **Apartment #:** **ZIP:** 08512

Survey Name: Cranbury Local Historic District Survey 2018

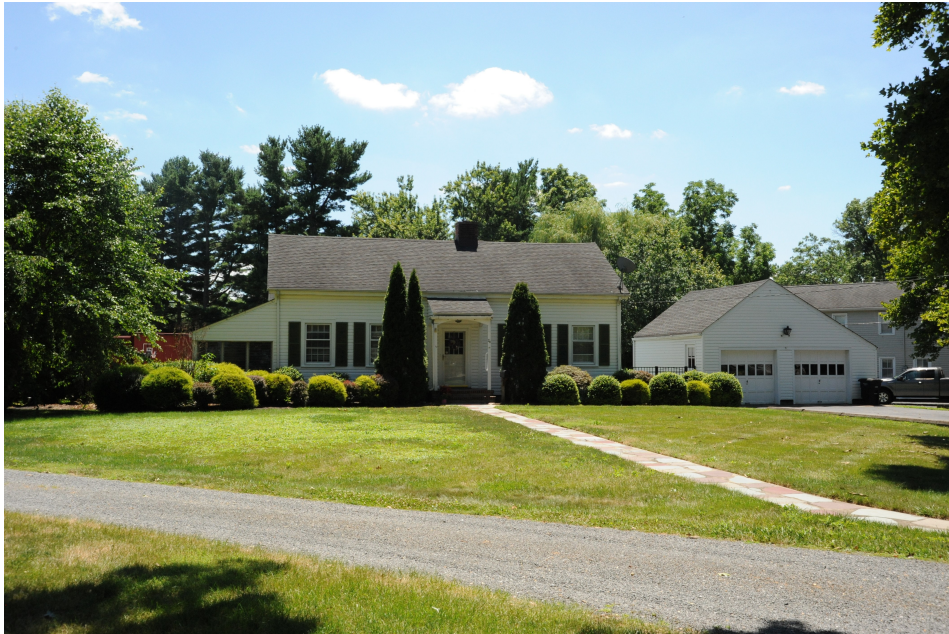
Property Photo:

The 1 ½-story, gable-roofed vinyl, siding-clad, rectangular-plan main block of this frame Colonial Revival-style dwelling on a concrete foundation is 5 bays wide and 2 bays deep and is fronted on the northwest by a 1-story, 1 bay-wide, centered shed-roofed porch on square-plan posts with segmental arch openings. A 1-story, shed-roofed, enclosed porch is on the northeast, side elevation. The roofs throughout are clad in asphalt shingle and the windows predominantly have 8/12, double-hung, historic wood sash. An interior, ridge, brick chimney is located just southwest of the center of the main volume. The primary entrance, centered on the main elevation, is accessed via the porch and includes a replaced door. Each of the remaining bays includes a window with applied vinyl shutters. The southwest elevation of the enclosed porch is lighted by a bank of jalousie windows. The southeast, side elevation is lighted by 2 windows on the first floor and a single window on the second floor. The northeast, rear elevation is lighted by a single window in each bay but the central bay, with a triple window in the second floor dormer. The northwest, side elevation, only partially visible from the public right-of-way, includes a secondary entrance and is lighted by jalousie windows in the west bay.

The 1-story, asymmetrical gable-roofed, vinyl siding-clad garage is 2 bays wide and includes 2 sectional garage doors on the southwest

elevation and a door on the northwest elevation.

This property is a contributing property in the historic district because it retains historic character-defining features such as its historic massing and fenestration patterns, historic windows and entrance porch.
