## PROPERTY REPORT

**Property Name:** 20 Maplewood Avenue **Ownership:** Private  
**Address:** 20 MAPLEWOOD AVE **Apartment #:** **ZIP:** 08512

**Survey Name:** Cranbury Local Historic District Survey 2018

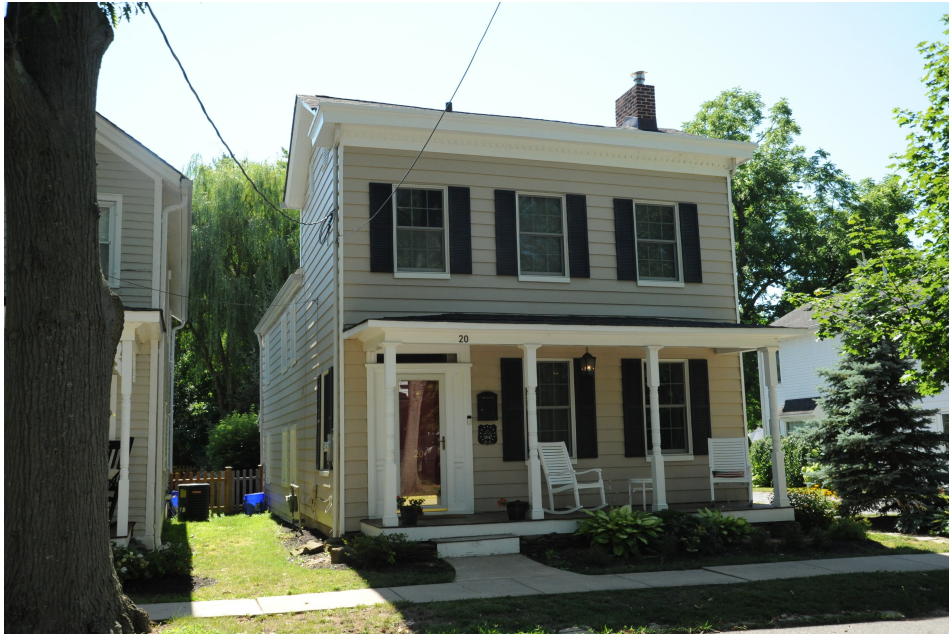
### Property Photo:

The 2-story, gable-roofed, rectangular plan, replacement clapboard-clad, main block of this frame dwelling on a parged foundation, 3 bays wide and 2 bays deep, is fronted on the northwest by a 1-story, full-width, hip-roofed porch and backed on the southeast by a partial-width, 2-story, gable-roofed, 3 bay deep secondary volume. A 1-story, shed-roofed, enclosed side porch flanks the rear volume on the southwest. The rear volumes are backed by a hip-roofed porch. The roofs are predominantly clad in asphalt shingle and the windows have replacement sash throughout. An interior, brick, ridge chimney is found near the southwestern end of the main volume, and a second interior, ridge, brick chimney is located on the rear volume. The primary entrance with historic transom and replaced door surround, is located in the northeast bay of the northwest elevation and is accessed by the front porch, which includes replaced posts. A window lights each of the remaining bays of each floor of the elevation. The southwest, side elevation is lighted by a window on each floor in the northwest bay. The rear enclosed porch volume includes a door and 2 windows on the first floor and 2 windows on the second floor. The southeast, rear elevation is not visible from the public right-of-way. The northeast, side elevation is lighted by a window in each bay of each floor of the rear volume with a single window in the west bay on the first floor of the main block.
