PROPERTY REPORT

Property Name: 14 Maplewood Avenue
Address: 14 MAPLEWOOD AVE

Survey Name: Cranbury Local Historic District Survey 2018

Organization: Paulus, Sokolowski & Sartor

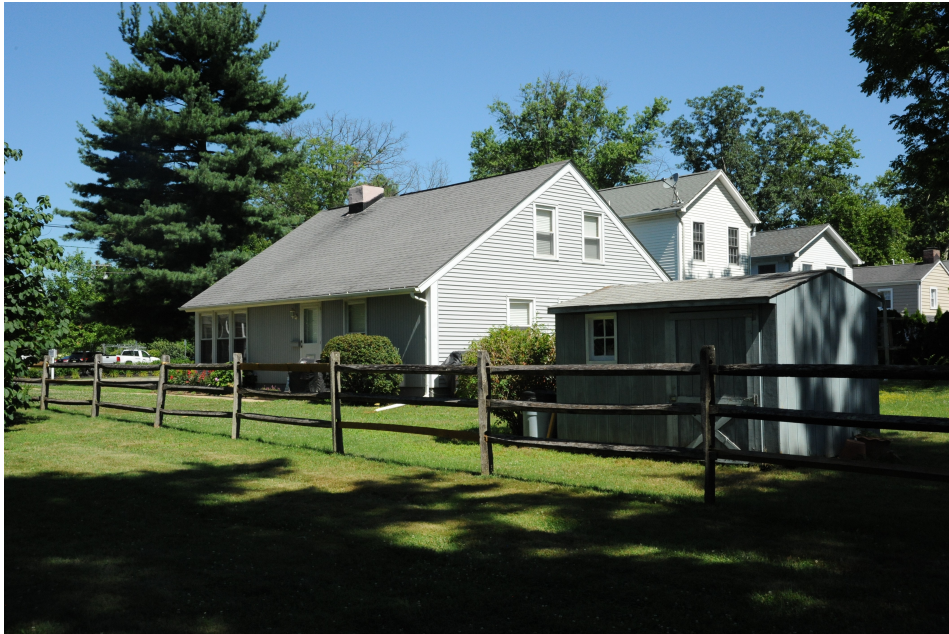
Property Photo:

The 1 ½-story, gable-roofed, rectangular plan, aluminum siding-clad, frame residence on a parged foundation is 3 bays wide and 3 bays deep. The roof is clad in asphalt shingles and the windows predominantly have 1/1 aluminum sash. A parged, interior chimney projects from the gable ridge in the northwest bay. The north and south elevations are clad in plywood siding. The southwest, main elevation includes the primary entrance door central bay, with a triple window in the northwest bay and a single window in the southeast bay. The northwest, street-facing elevation and southeast, side elevation are both lighted by a window in each bay of the first floor with 2 windows on the second floor. The northeast, rear elevation includes a secondary door in the central bay and a single window in the southeast and northwest bays.
