PROPERTY REPORT

Property Name: 10 Maplewood Avenue
Address: 10 MAPLEWOOD AVE

Survey Name: Cranbury Local Historic District Survey 2018

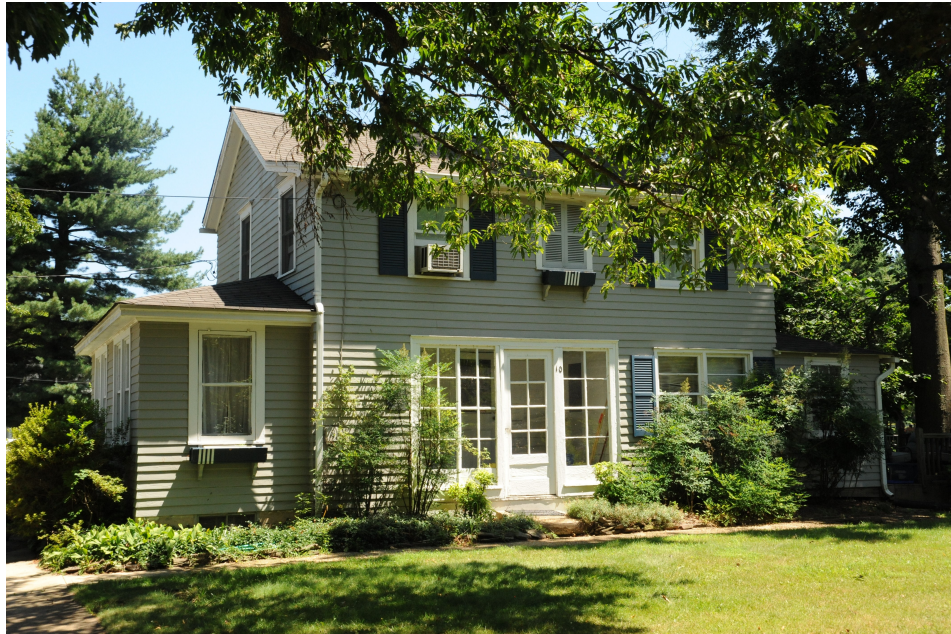
Property Photo:

The 2-story, gable-roofed, rectangular plan, main volume of this frame, painted clapboard-clad dwelling on a parged foundation is 2 bays wide and 3 bays deep. The main volume flanked on the northwest by a 1-story, hip-roofed, enclosed porch, and by a 1-story, shed and hip-roofed volume on the southeast. The roofline of the main volume changes pitch over an addition on the southwest where a second story was placed over an earlier porch. The roofs throughout are clad in asphalt shingle and the windows have 1/1 and horizontal 2/2 wood sash. The residence is accessed by an enclosed, recessed porch on the southwest, main elevation. An 8-light wood door flanked by 2, 8-light windows on the left and 1 on the right is located in the west bay. A double window lights the east bay, with a single window in each of the bays on the second floor. A single window lights the southwest elevation of each of the 1-story volumes. The southeast, side elevation is not visible from the public right-of-way. The northeast, rear elevation includes a single window in each of the outer bays of both floors of the main volume, with a single 6-light casement window in the rear volume. The northwest, street-facing elevation has a double window in each bay of the 1-story volume, a single, central window on the second floor beneath the gable, and a window in the south bay beneath the adjusted roofline.
