New Jersey Department of Environmental Protection Historic Preservation Office

# PROPERTY REPORT

Property Name:4 Maplewood AvenueOwnership:PrivateAddress:4 MAPLEWOOD AVEApartment #:ZIP:08512

Survey Name: Cranbury Local Historic District Survey 2018

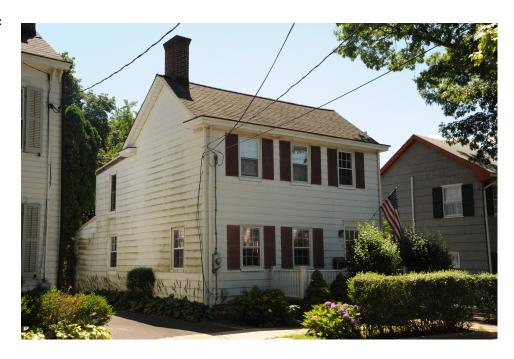
### **Property Photo:**

PS&S recommends that the residence at 4 Maplewood Avenue, constructed between 1850 and 1876, is a contributing property in the Cranbury Historic District. The property includes a non-contributing manufactured storage shed.

The 2-story, rectangular-plan, gable-roofed, aluminum siding-clad, main volume of this frame dwelling on a parged foundation is 3-bays wide and 2-bays deep and is backed on the southeast by a 2-story, shed-roofed, 1-bay deep rear volume. A 1-story, shed-roofed rear el projects from the 2-story rear volume. A 2-story, hip-roofed, cedar shingle-clad, side volume on a concrete foundation projects from the southeast corner of the building. The visible roofs throughout are clad in asphalt shingle, and the windows throughout the main volume contain historic 6/6 wood sash with replaced, applied shutters. An interior brick chimney projects from the north bay of the gable ridge. The concrete porch includes a replaced rail. The residence is accessed by a replaced, 16-light door in the southwest bay of the northwest, main elevation. Each of the remaining bays of the main elevation contains a window on both floors. The southwest, side elevation includes 2/2 windows on the first floor of the side volume and a bank of fixed, 4-light windows on the second floor. The southeast, rear elevation is not visible from the public right-of-way. The northeast, side elevation includes a window in the northwest bay of the first floor and a window on each floor of the 2-story rear volume.

This property is a contributing property in the historic district because it retains integrity and such character-defining historic features as the massing and fenestration pattern of its main volume, historic brick chimney, and historic wood window sash.
