PROPERTY REPORT

Property Name: 2 Maplewood Avenue
Address: 2 MAPLEWOOD AVE

Survey Name: Cranbury Local Historic District Survey 2018

Organization: Paulus, Sokolowski & Sartor

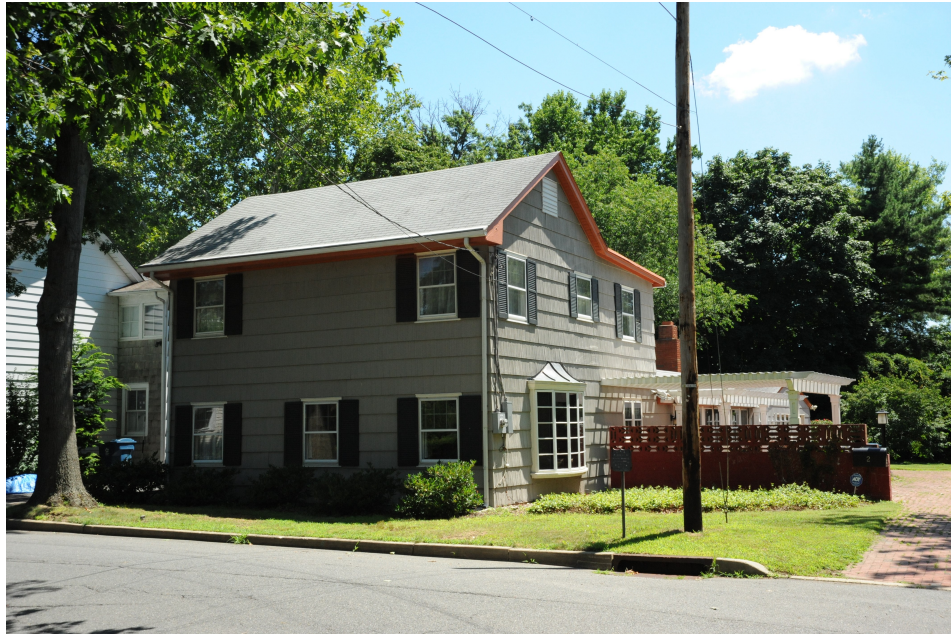
Property Photo:

The 2-story, rectangular-plan, gable-roofed, asbestos shingle-clad, main volume of this frame residence on a shingle-covered foundation, 3 bays wide and 2 bays deep, is backed on the southeast by a 2-story, shed-roofed, full-width, 1-bay deep rear volume. The main block is backed in turn by a 1-story, gable-roofed rear volume connects the main residence to a 1-story, cross gable-roofed garage. A substantial 1-story trellis projects over the patio on the south, side elevation. The roofs throughout are clad in asphalt shingle and the windows predominantly contain 6/1 replacement wood sash with replacement wood shutters. An interior brick chimney projects from the 1-story rear addition. The primary entrance, located on the southwest, side elevation, is not visible from the public right-of-way. The northwest, street-facing elevation includes a window in each bay but the central bay of the second floor. The southwest, side elevation includes a bow-plan window oriel on the first floor with a window in each bay of the second floor. The 2-story rear volume includes a vinyl double window on the first floor and a window on the second floor. The 1-story rear volume, only partially visible from the public right-of-way, includes a bank of windows in the eastern bay. The southeast, rear elevation is not visible from the public right-of-way. The northeast, side elevation includes 3 small windows on the first floor and 2 windows on the second floor, with 1 in the west bay of the main volume and 1 in the rear volume.

PS&S recommends that the residence at 2 Maplewood Avenue, built or substantially altered in the 1960s, is a non-contributing property in the Cranbury Historic District.

This property is non-contributing to the historic district by virtue of its extensive alterations or rebuilding after the period of significance.
