PROPERTY REPORT

Property Name: 2 Scott Avenue **Ownership:** Private
Address: 2 SCOTT AVE **Apartment #:** **ZIP:** 08512

Survey Name: Cranbury Local Historic District Survey 2018

District Name: Cranbury Historic District

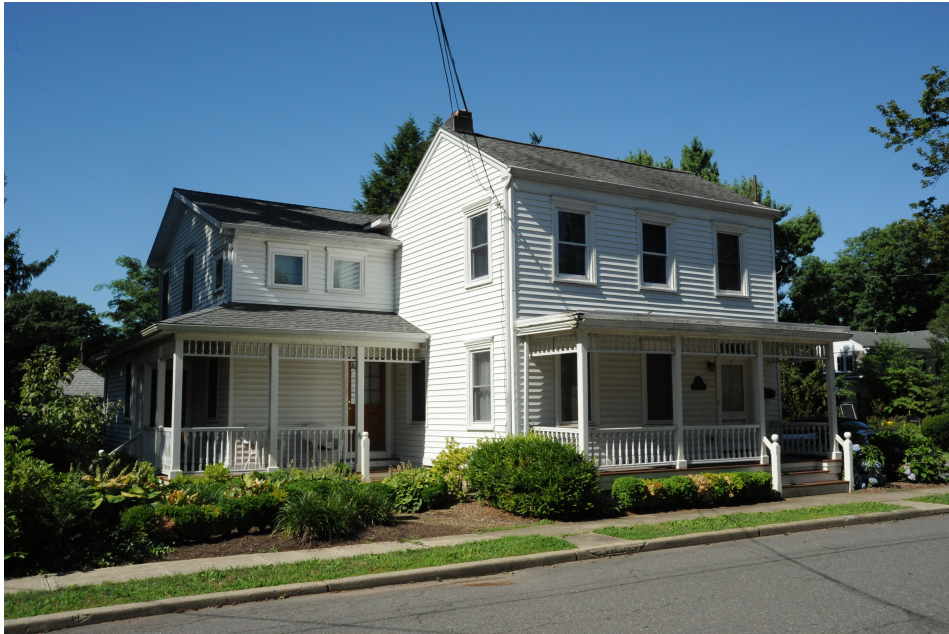
Property Photo:

The 2-story, side gable-roofed, rectangular-plan main block of this aluminum siding-clad, frame dwelling on a parged foundation is 3 bays wide and 2 bays deep and is fronted on the northeast by a 1-story, composite-roofed, full-width porch and backed on the southwest by a 2-story, gable-roofed volume. A 2-story, side gable-roofed addition on the southeast of the rear volume projects beyond the southeast elevation of the main volume and is fronted by a hipped-roofed porch that wraps around its southeast side. The roofs are predominantly clad in asphalt shingle and the windows have 1/1 replacement sash that are probably historic. The front porch, accessed by a straight stair in the northwest bay with historic rail and newel posts, includes square-plan posts with beveled corners, a historic rail with turned balusters, and a historic spindle frieze. The primary entrance, located in the northwest bay, includes a historic door with a single light over a recessed panel and a single light, historic transom. The remaining bays of both floors are regularly fenestrated. The porch of the added volume is accessed by 2s stairs in the northwest bay of the northeast elevation and the northeast bay of the southeast elevation and includes square-plan posts with beveled corners, a spindle frieze, and a rail with balusters that mimic those of the main volume. A secondary entrance, located in the northwest bay, includes a door with a 9-light window over recessed panels. The second floor is lighted by 2 casement or awning windows. Another secondary entrance to the rear of the residence is located on the northwest elevation of an enclosed porch bay. The northwest, side elevation of the main volume is lighted on the first floor by a single window and under the gable-

end by a replaced, single-light, double window. The rear volume is regularly fenestrated and accessed by a recessed entry with a shed-roofed door-hood with simple triangular brackets. The windows of the first floor include single light transoms. The southwest, rear elevation is not visible from the public right-of-way.

2 Scott Avenue is a contributing property in the Cranbury Historic District because it retains integrity and historic character-defining features, such as its historic porch rail and balusters, historic spindle frieze, historic door, and historic chimney. However, the replacement of surface materials and window sash and the visibility of the rear volume from the public right-of-way render this status marginal.
