PROPERTY REPORT

Property Name: 6 North Main Street
Address: 6 N Main ST
Apartment #:
Ownership: Private
ZIP: 08512

Survey Name: Cranbury CLG Survey 2017

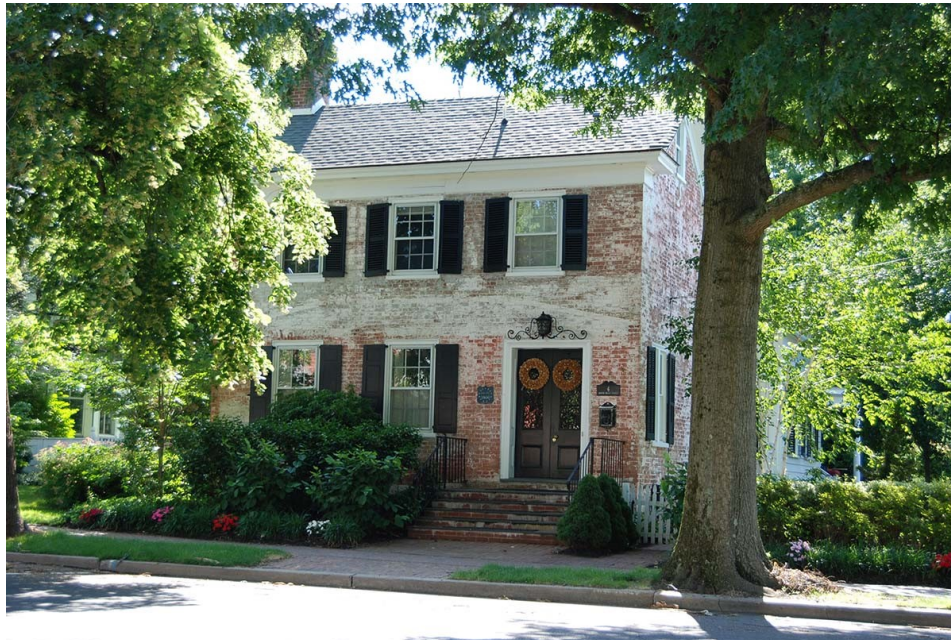
Property Photo:

6 North Main Street is a two-story, three-bay, two-pile Federal residence constructed circa 1800. The house has a two-story rear ell section and a one-story rear addition.

The main block has a side-gabled roof sheathed with asphalt shingles. The molded cornice is located above an expressed frieze. An exterior brick chimney is attached onto the north end of the house at the ridgeline, breaking through the cornice. The exterior of the dwelling is of whitewashed brick, and vestigial ("ghost") markings indicate the former roofline of a now-removed hipped roof porch. Fenestration is symmetrically arranged. Windows are six-over-six double-hung, wood-sash (possibly original) with brick jack arches. Paneled shutters flank the windows on the first floor, while the shutters on the second floor are louvered. The entrance, located in the southwest corner of the dwelling, consists of paired, one-panel wood doors in a molded surround with elaborate three-light filigree designs. The entrance is accessed via a brick pad porch with metal railings. The house has a stone foundation.
