PROPERTY REPORT

Property Name: John Lewis House **Ownership:** Private
Address: 2 N Main ST **Apartment #:** **ZIP:** 08512

Survey Name: Cranbury CLG Survey 2017

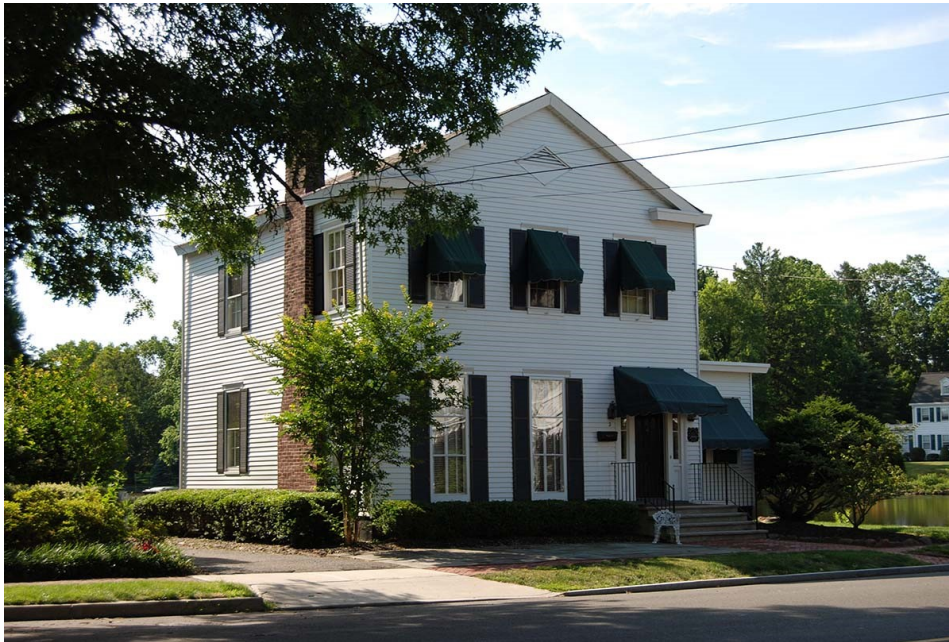
Property Photo:

The John Lewis House at 2 North Main Street is a two-story, three-bay, two-pile private residence constructed circa 1850. The house faces west onto North Main Street and has a one-story addition on the south elevation that wraps onto the east (rear) elevation.

The front gabled roof is sheathed with asphalt shingles. The molded raking cornice includes returns that help frame a diamond-shaped attic louver. An exterior brick chimney on the north elevation is engaged but still breaks through the eaves. The exterior of the dwelling is clad in vinyl siding. Fenestration is symmetrically arranged, with three bays of windows and the front door, aligned horizontally and vertically. The second floor has three six-over-six, double-hung, wood-sash (possibly original) windows with aluminum storm windows and louvered, inoperable shutters. The first floor has two wood walk-out windows dating to the late nineteenth century in the north and center bays, each with door shutters. The main entrance in the south bay consists of a wood door with two vertical panels (late nineteenth century) opening below a transom and between two-pane sidelights over a recessed panel. Green fabric awnings cover the entrance and windows. The entrance is accessed via a concrete porch with metal railings and a brick landing. The house has a stone foundation.

The north elevation faces onto the property drive. The asphalt-shingled roof and the attached brick chimney are major features of the elevation. The vinyl-clad walls feature a rank of windows on either side of the chimney. The windows are six-over-six, double-hung, wood-sash (possibly original) units with louvered, inoperable shutters.

The south elevation repeats the cladding materials of the main elevation: asphalt shingles on the roof and vinyl-clad frame walls. The molded cornice is visible on this elevation. The wall surface contains two ranks of windows separated by a wide expanse of wall surface. The windows are six-over-six, double-hung, wood-sash (possibly original) units with louvered, inoperable shutters.

A one-story, L-shaped addition abuts the main block to the south and east. The addition was constructed in several campaigns, and the various rooflines of the individual sections do not match. An octagonal bay is located on the south elevation of the addition. Overall, the addition has a nearly flat roof, and its frame walls are clad with vinyl siding. Windows vary in size and shape; they are multi-light units that all appear to be late twentieth century replacement vinyl sash units. The addition has a concrete foundation, and brick steps in the rear access a door not visible from the public right-of-way.

Character defining elements of the dwelling include return cornices on the front (northwest) elevation and sidelights flanking the entrance.
