PROPERTY REPORT

Property Name: John Lewis House

Address: 2 N Main ST

Survey Name: Cranbury CLG Survey 2017

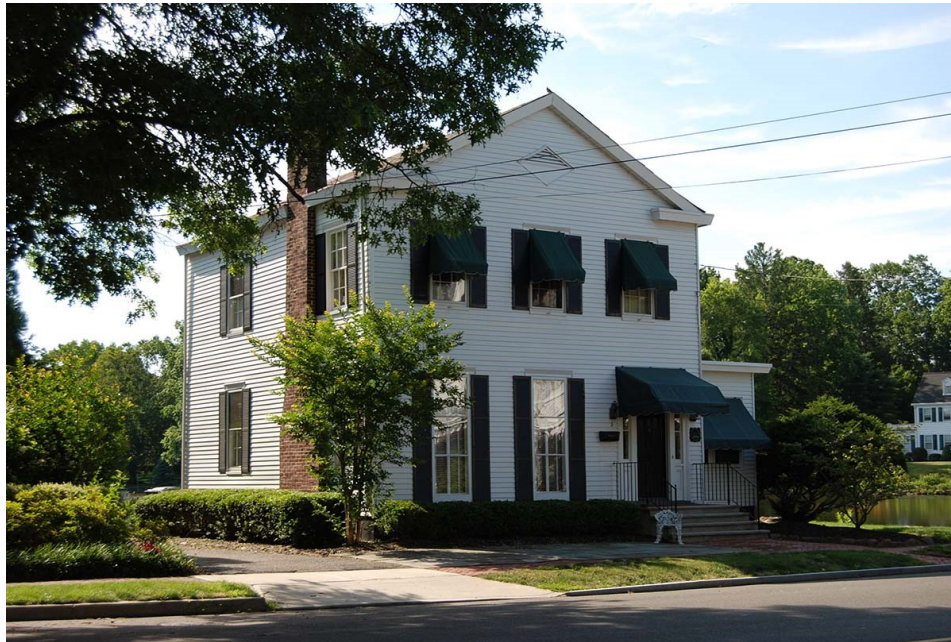
Property Photo:

The John Lewis House at 2 North Main Street is a two-story, three-bay, two-pile private residence constructed circa 1850. The house faces west onto North Main Street and has a one-story addition on the south elevation that wraps onto the east (rear) elevation.

The front gabled roof is sheathed with asphalt shingles. The molded raking cornice includes returns that help frame a diamond-shaped attic louver. An exterior brick chimney on the north elevation is engaged but still breaks through the eaves. The exterior of the dwelling is clad in vinyl siding. Fenestration is symmetrically arranged, with three bays of windows and the front door, aligned horizontally and vertically. The second floor has three six-over-six, double-hung, wood-sash (possibly original) windows with aluminum storm windows and louvered, inoperable shutters. The first floor has two wood walk-out windows dating to the late nineteenth century in the north and center bays, each with door shutters. The main entrance in the south bay consists of a wood door with two vertical panels (late nineteenth century) opening below a transom and between two-pane sidelights over a recessed panel. Green fabric awnings cover the entrance and windows. The entrance is accessed via a concrete porch with metal railings and a brick landing. The house has a stone foundation.

The north elevation faces onto the property drive. The asphalt-shingled roof and the attached brick chimney are major features of the elevation. The vinyl-clad walls feature a rank of windows on either side of the chimney. The windows are six-over-six, double-hung, wood-sash (possibly original) units with louvered, inoperable shutters.

The south elevation repeats the cladding materials of the main elevation: asphalt shingles on the roof and vinyl-clad frame walls. The molded cornice is visible on this elevation. The wall surface contains two ranks of windows separated by a wide expanse of wall surface. The windows are six-over-six, double-hung, wood-sash (possibly original) units with louvered, inoperable shutters.

A one-story, L-shaped addition abuts the main block to the south and east. The addition was constructed in several campaigns, and the various rooflines of the individual sections do not match. An octagonal bay is located on the south elevation of the addition. Overall, the addition has a nearly flat roof, and its frame walls are clad with vinyl siding. Windows vary in size and shape; they are multi-light units that all appear to be late twentieth century replacement vinyl sash units. The addition has a concrete foundation, and brick steps in the rear access a door not visible from the public right-of-way.

Character defining elements of the dwelling include return cornices on the front (northwest) elevation and sidelights flanking the entrance.
