## PROPERTY REPORT

**Property Name:** William Hillyer House **Ownership:** Private  
**Address:** 1 S MAIN ST **Apartment #:** **ZIP:** 08512

**Survey Name:** Cranbury Local Historic District Survey 2018

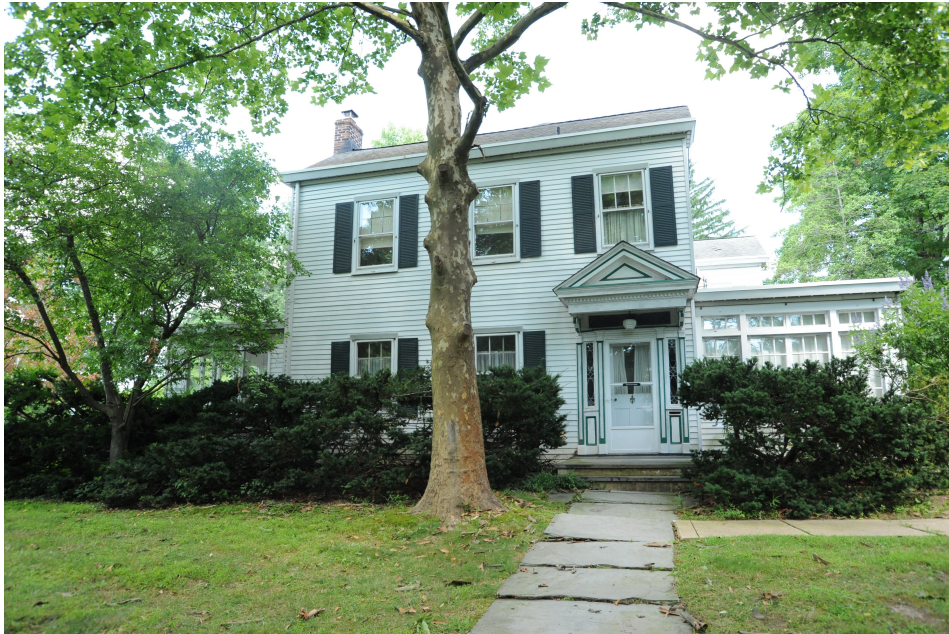
### Property Photo:

The 2 1/2-story, side gable-roofed, rectangular-plan main block of this aluminum siding-clad, frame dwelling on a covered foundation is 3 bays wide and 2 bays deep and is backed on the southeast by a 2 1/2-story, cross gable-roofed, L-plan secondary volume. A 1-story, hip-roofed, enclosed porch is on the northeast, side elevation of the main block and a 1-story, composite-roofed, enclosed porch is on the southwest, side elevation. The roofs are predominantly clad in asphalt shingle and the windows predominantly have 6/1 historic wood sash. An exterior brick chimney projects from the northeast elevation of the main block. The primary entrance is located in the southwest bay of the northwest, main elevation and includes a historic, replaced door surround with leaded glass sidelights, a single light transom, and a Colonial Revival, pedimented door hood with brackets and dentils. The northeast, side enclosed porch is lighted by a triple window. The southwest, side enclosed porch is lighted a bank of four 12-light windows with 3-light transoms. The southwest, side elevation is only partially visible from the public right-of-way and is lighted in the enclosed porch by 2 sets of double 12-light windows flanked by 4-light sidelights with a single 7-light transom flanked by single lights. The second floor of the main block is lighted by a single window in the west bay with a single window on the third floor. The rear volume is fronted by a shed-roofed porch and includes a secondary door in the east bay and a window in the west bay, with a replaced sliding window on the second floor. The projecting rear volume is lighted in each bay by

a single window. The southeast, rear elevation is not visible from the public right of way. The northeast, side elevation is only partially visible and includes single and double windows on the second floor of the rear volume, single windows on the second floor of the main volume, and 2 triple windows lighting the enclosed porch.

The residence at 1 S. Main Street is a contributing property in the Cranbury Historic District because it retains integrity and character-defining historic features such as its historic windows, historic added door hood and door surround, historic chimney, and unaltered massing of the main block. The wagon-house retains its historic doors, vertical board siding, and eave projecting. The garage retains its historic 6-light, multi-leaf sliding door.
