## PROPERTY REPORT

**Property Name:** 62 Maplewood Avenue  
**Address:** 62 MAPLEWOOD AVE

PS&S recommends that 62 Maplewood Avenue, built in the 1910s, contributes to the Cranbury Historic District. The historic garage contributes to the property.

**Survey Name:** Cranbury Local Historic District Survey 2018

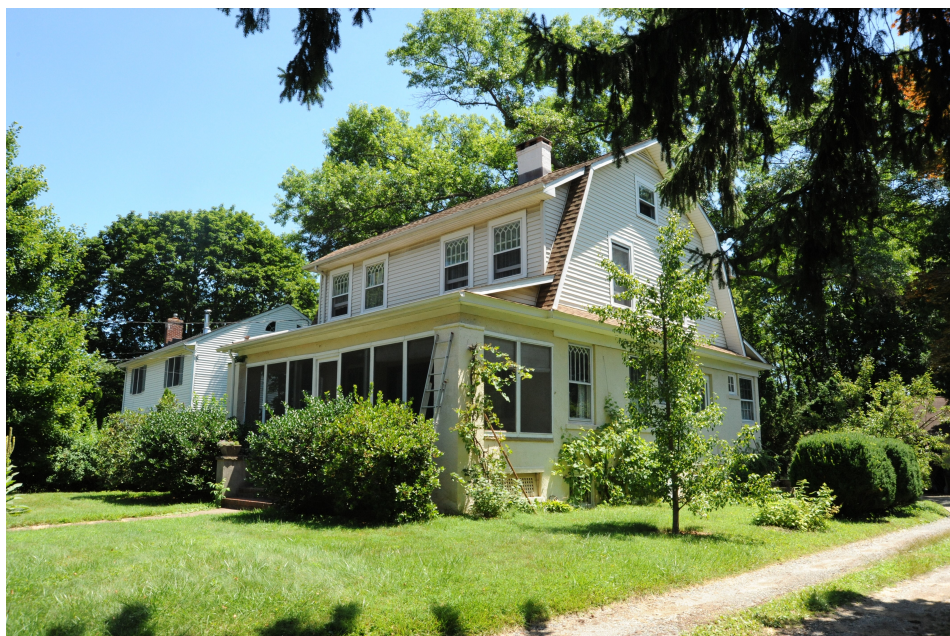
### Property Photo:

This 2 1/2-story, gambrel-roofed, rectangular-plan dwelling with a stuccoed concrete block first floor and basement and aluminum siding-clad, frame upper section is 5 bays wide and 3 bays deep and is fronted on the northwest by a 1-story, shed-roofed, screened-in porch and backed by a 1-story, partial-width, shed-roofed secondary volume. The roofs are clad in asphalt shingle and the windows predominantly have double-hung historic wood sash with a multi-light upper sash that includes extended narrow lights beneath a row of diamond pattern lights. A stuccoed, ridge chimney is centered on the main volume roof. The front porch includes a stuccoed knee wall and substantial stuccoed corner posts and is accessed by a straight brick stair with stuccoed cheek walls. The primary, centered entrance includes a historic door with a large, single light flanked by historic, large, single sidelights. A window on each side of the door lights the first floor, with 4 windows in the outer bays of the second floor. The southwest, side elevation is asymmetrically fenestrated and is lighted in the rear volume by a 6/6 sash and a 4-light casement window. Windows with 1/1 sash light the second floor, and a small, 1/1 sash window lights the third floor. The southeast, rear elevation is not visible from the public right-of-way. The northeast, side elevation is only partially visible from the public right-of-way and includes a 1-story, rectangular-plan, projecting window bay in the southeast bay of the first floor. The northwest bay is lit by 3 windows and a triple window lights the projecting bay. The second floor is lighted by 2 1/1 windows with

a small 1/1 window on the third floor.

A 1-story, gable-roofed, frame garage is located to the southeast of the residence.

This property is a contributing property in the historic district because it retains integrity and historic character-defining features such as its historic massing and fenestration patterns, historic chimney, and its historic windows and doors.
