PROPERTY REPORT

Property Name: 60 Maplewood Avenue
Address: 60 MAPLEWOOD AVE

PS&S recommends that 60 Maplewood Avenue, constructed in the mid-19th century, is a contributing property in the Cranbury Historic District. The small secondary buildings near the rear of the property are non-contributing.

Survey Name: Cranbury Local Historic District Survey 2018

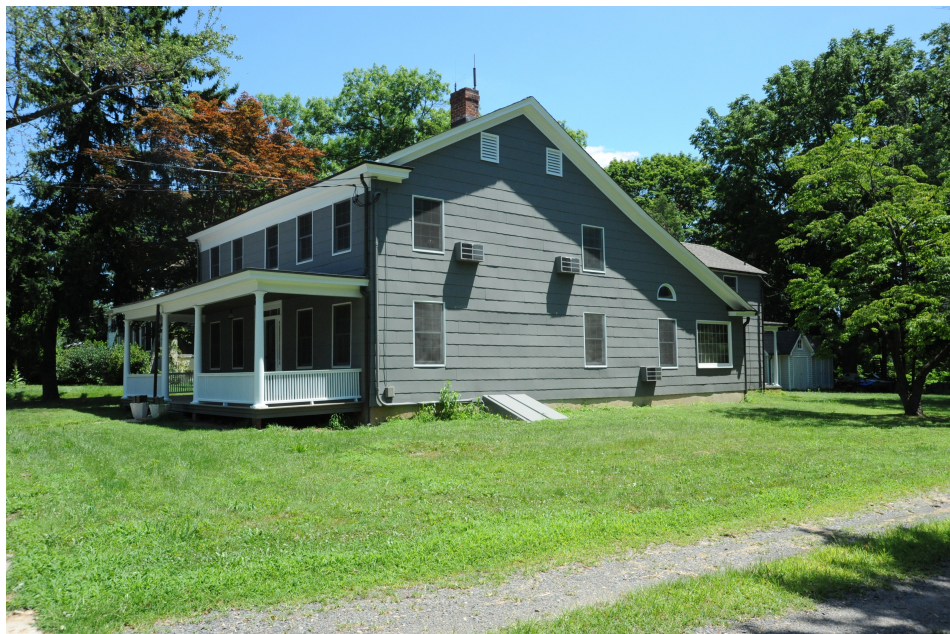
Property Photo:

The 2-story, asymmetrical gable-roofed main block of this frame, T-plan, asbestos shingle-clad dwelling on a parged foundation is 5 bays wide and 4 bays deep and is fronted on the northwest by a 1-story, hip-roofed, full-width porch and backed by a 2-story, gable-roofed, partial-width secondary volume. A 1-story, hip-roofed porch backs the rear volume, and a 1-story, hip-roofed volume backs the main block. The roofs are predominantly clad in asphalt shingle and the windows throughout have replacement sash. An interior, brick, ridge chimney is located toward the southwest elevation of the main block. The front porch includes replaced columns and a replaced rail with square-plan balusters. The primary, centered entrance includes an altered door in a historic surround, with a 4-light transom and sidelights. The remaining bays on both floors are regularly fenestrated. The southeast, side elevation is asymmetrical fenestrated and includes a half-round window and large picture window in the south bays. The southeast, rear elevation is not visible from the public right-of-way. The northeast, side elevation is only partially visible from the public right-of-way and is regularly fenestrated. There are 2 gable-roofed frame sheds are located east of the residence.

This property is a contributing property in the historic district because it retains integrity and historic character-defining features such as its historic massing and fenestration patterns, historic brick chimney, and some historic porch details.
