## PROPERTY REPORT

**Property Name:** 56 Maplewood Avenue  
**Address:** 56 MAPLEWOOD AVE

**Survey Name:** Cranbury Local Historic District Survey 2018

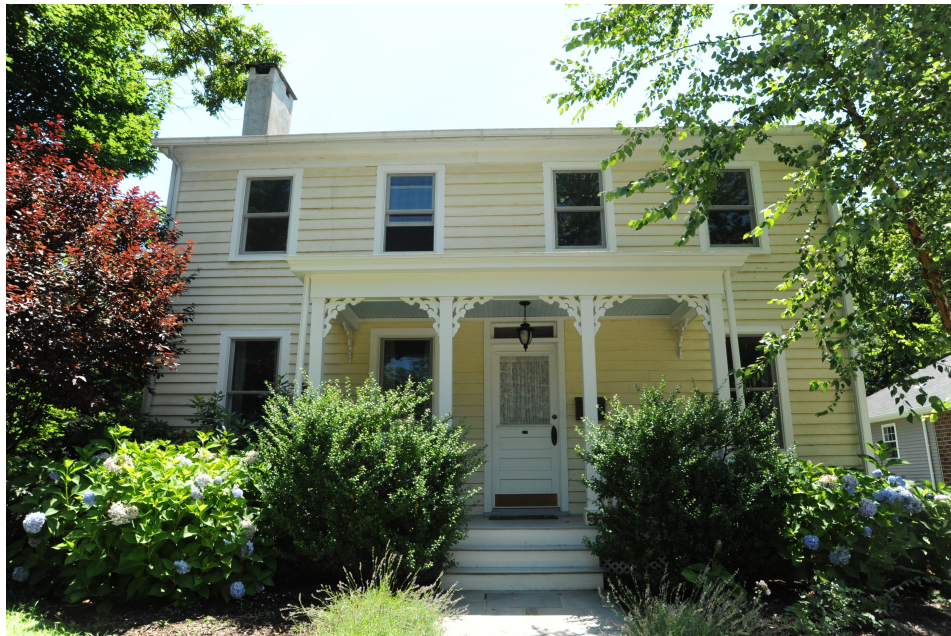
### Property Photo:

The 2-story, gable-roofed, T-plan, main block of this clapboard and aluminum siding-clad, frame dwelling on a parged foundation is 4 bays wide and 4 bays deep and is fronted by a 1-story, composite-roofed porch and backed by a 1-story, gable-roofed rear volume. A partially recessed side porch is located on the southwest elevation of the rear volume. The roofs throughout are clad in asphalt shingle and the windows have 1/1 replacement vinyl sash. Interior, stuccoed, ridge chimneys are located on the northeast end of the main block and on the southeast end of the rear addition. The front porch on the northwest, main elevation includes square-plan posts with beveled edges, decorative scroll brackets, and a simple rail with square-plan balusters. The primary entrance, roughly centered, includes a historic, large light door with historic single light transom. Each of the remaining bays on both floors are regularly fenestrated. The southwest, side elevation is lighted by a window on each floor of the northwest bay and by a single window on the first floor and 2 windows on the second floor of the southeast bay. The rear volume is accessed by a porch with replaced turned posts. A secondary entrance is located in the west bay of the rear addition, with a single window in the remaining bay. The southeast, rear elevation is not visible from the public right-of-way. The northeast, side elevation is only partially visible from the public right-of-way and is asymmetrically fenestrated.

The 1-story, hip-roofed, frame garage with sliding door is located to the southeast of the residence.

This property is a contributing property in the historic district because it retains integrity and historic character-defining features such as its historic fenestration patterns and some historic porch details. The extent of replacement of these materials, and the visibility of the rear addition from the public right-of-way make this status very marginal.
