PROPERTY REPORT

Property Name: 56 Maplewood Avenue **Ownership:** Private
Address: 56 MAPLEWOOD AVE **Apartment #:** **ZIP:** 08512

Survey Name: Cranbury Local Historic District Survey 2018

Organization: Paulus, Sokolowski & Sartor

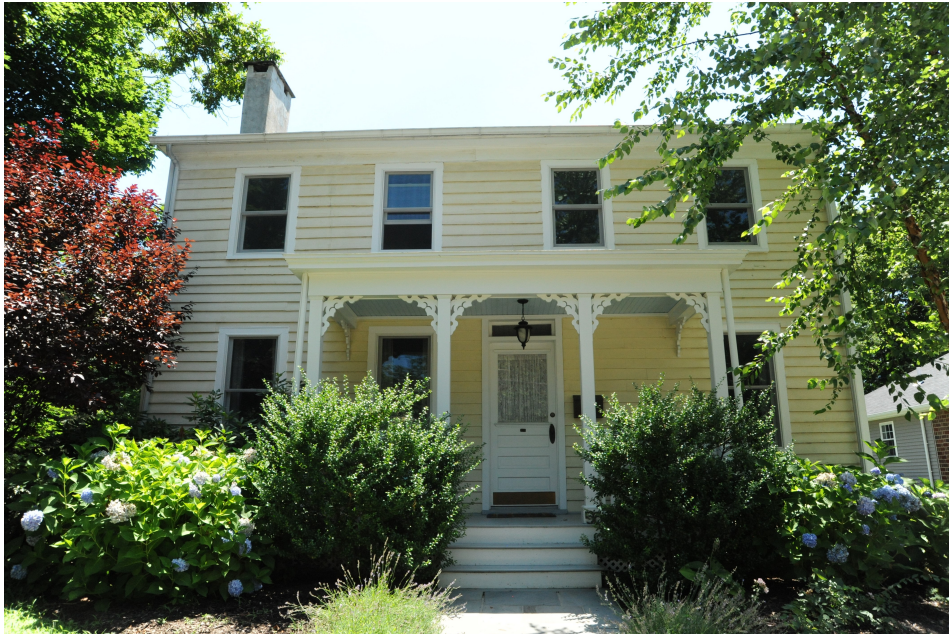
Property Photo:

The 2-story, gable-roofed, T-plan, main block of this clapboard and aluminum siding-clad, frame dwelling on a parged foundation is 4 bays wide and 4 bays deep and is fronted by a 1-story, composite-roofed porch and backed by a 1-story, gable-roofed rear volume. A partially recessed side porch is located on the southwest elevation of the rear volume. The roofs throughout are clad in asphalt shingle and the windows have 1/1 replacement vinyl sash. Interior, stuccoed, ridge chimneys are located on the northeast end of the main block and on the southeast end of the rear addition. The front porch on the northwest, main elevation includes square-plan posts with beveled edges, decorative scroll brackets, and a simple rail with square-plan balusters. The primary entrance, roughly centered, includes a historic, large light door with historic single light transom. Each of the remaining bays on both floors are regularly fenestrated. The southwest, side elevation is lighted by a window on each floor of the northwest bay and by a single window on the first floor and 2 windows on the second floor of the southeast bay. The rear volume is accessed by a porch with replaced turned posts. A secondary entrance is located in the west bay of the rear addition, with a single window in the remaining bay. The southeast, rear elevation is not visible from the public right-of-way. The northeast, side elevation is only partially visible from the public right-of-way and is asymmetrically fenestrated.

The 1-story, hip-roofed, frame garage with sliding door is located to the southeast of the residence.

This property is a contributing property in the historic district because it retains integrity and historic character-defining features such as its historic fenestration patterns and some historic porch details. The extent of replacement of these materials, and the visibility of the rear addition from the public right-of-way make this status very marginal.
