PROPERTY REPORT

Property Name: 30 Maplewood Avenue
Address: 30 MAPLEWOOD AVE

Survey Name: Cranbury Local Historic District Survey 2018

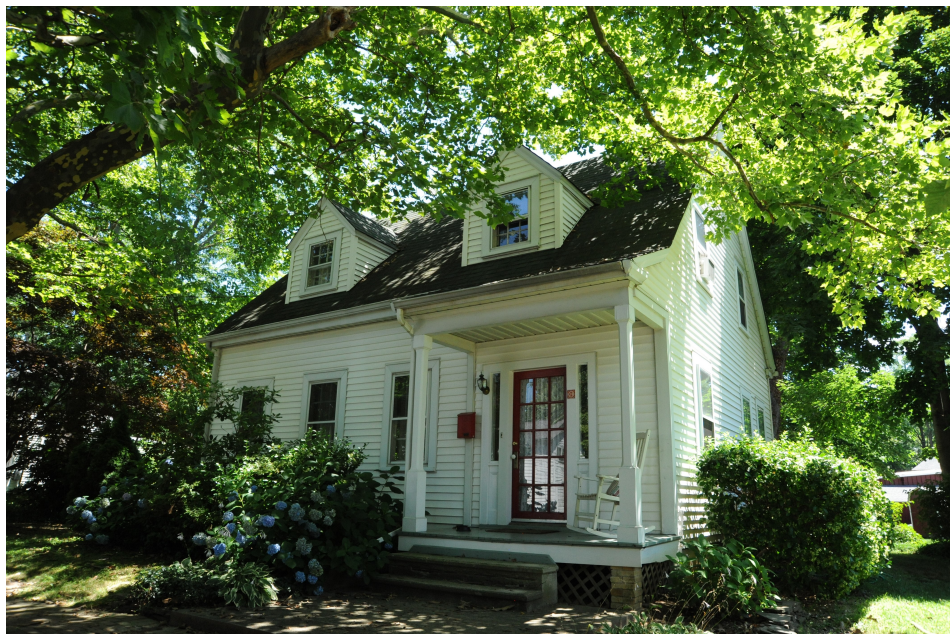
Property Photo:

The 1 ½-story, gable-roofed, rectangular plan, vinyl siding-clad, main block of this frame dwelling on a concrete foundation is 4 bays wide and 3 bays deep and is fronted on the northwest by a 1-story, shed-roofed front porch and backed on the southeast by a 1-story, partial-width, centered, shed-roofed el. The roofs are clad in asphalt shingle and the windows have 6/6, double-hung, historic wood sash. The roof includes an interior stuccoed chimney in the central bay of the gable ridge and a shed-roofed dormer in the central bay of the southeast slope. The front porch is 1 bay wide in the southwest corner of the main elevation and includes replaced posts. The replaced, 16-light door in the primary entrance of the residence is accessed by the porch and includes a historic door surround with historic, single-light sidelights. The southwest, side elevation is lighted by a window in each bay of the first floor, with 2 windows on the second floor. The southeast, rear elevation is not visible from the public right-of-way. The northeast, side elevation is lighted by a window in the outer bays of the first floor and 2 windows on the second floor.

A 1-story, gable-roofed, frame garage, not visible from the public right-of-way, is located to the southeast of the residence.

This property is a contributing property in the historic district because it retains integrity and historic character-defining features such as its historic massing and fenestration patterns, historic porch, historic windows, and historic chimney.
