PROPERTY REPORT

Property Name: Main Street Bridge over Cranbury Brook

Survey Name: Cranbury Historic Sites Survey Phase III

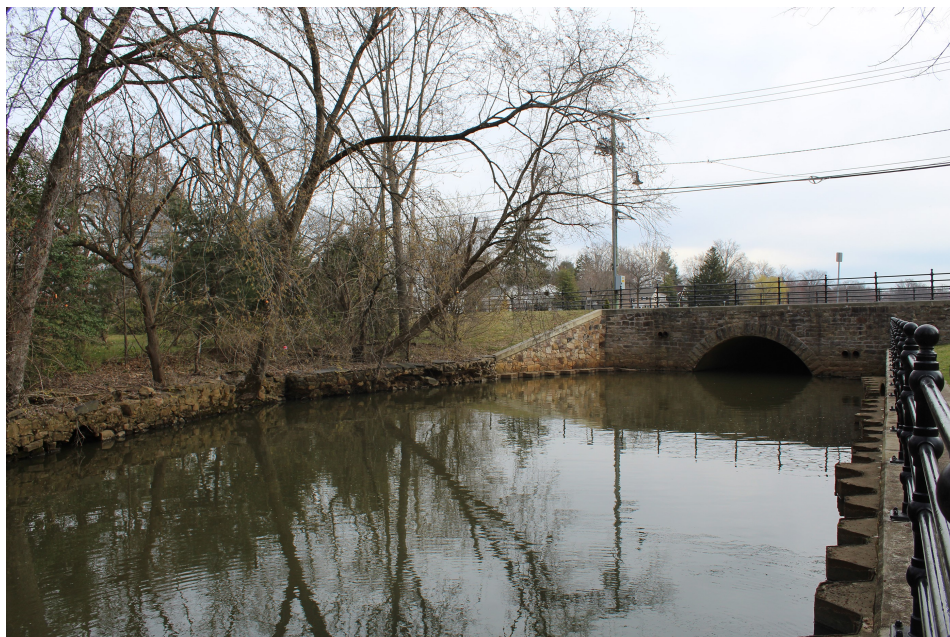
Property Photo:

The Main Street Bridge over Cranbury Brook is a single-span, brick barrel arch bridge constructed in 1896. The bridge measures 23 feet in length, 34 feet, 6 inches in width, and carries two lanes of Main Street over Cranbury Brook. Main Street travels on a north-south alignment over the bridge, flanked by concrete sidewalks and four-rail, metal pipe railings (added 2014, similar in appearance to historic railings). The bridge is supported by coursed rubble stone spandrels and wingwalls, capped in concrete with utility pipe cuts. The east and west faces of the arch are lined with stone voussoirs. The intrados of the arch are coated with gunite (added in 1987). Adjacent to the upstream (east) face of the bridge, Cranbury Brook is dammed with a concrete spillway to form Brainerd Lake. The upstream approaches are reinforced with concrete buttresses. A coursed rubble stone retaining wall extends from the northwest bank to the roadway.

Character-defining elements of the Main Street Bridge over Cranbury Brook include its brick barrel arch, coursed rubble stone spandrels and wingwalls, and four-rail, metal pipe railings
