PROPERTY REPORT

Property Name: 54 Maplewood Avenue
Address: 54 MAPLEWOOD AVE

PS&S recommends that 54 Maplewood Avenue, constructed in the 1930s, is a contributing property in the Cranbury Historic District.

Survey Name: Cranbury Local Historic District Survey 2018

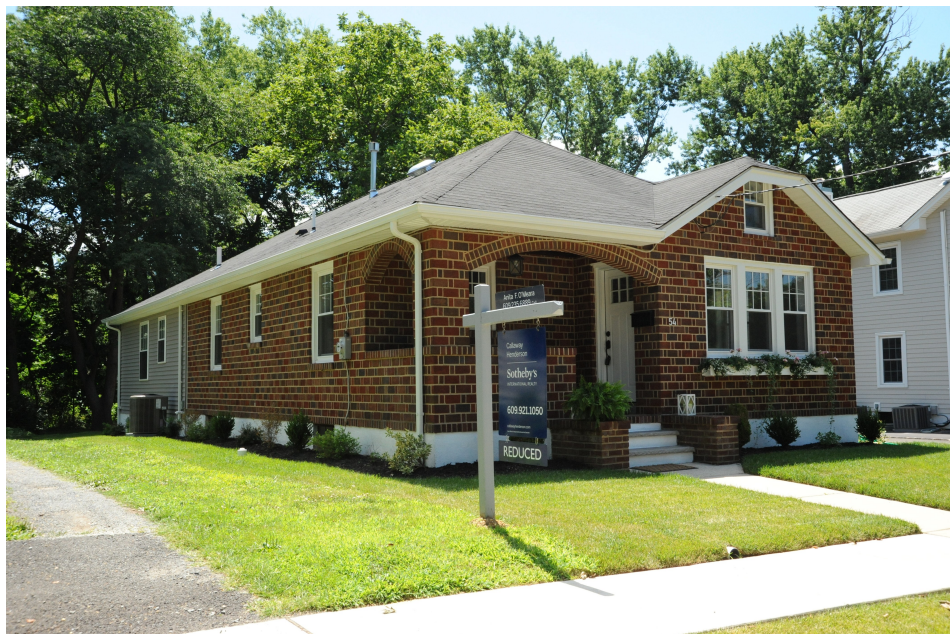
Property Photo:

The 1-story, hip-roofed, rectangular plan, Flemish bond brick bungalow on a parged foundation is 2 bays wide and 3 bays deep and is fronted by a 1-story, jerkinhead-roofed entry volume and a recessed porch. A 1-story frame addition backs the main volume on the southeast. The roofs throughout are clad in asphalt shingle and the windows throughout have 6/1 replacement vinyl sash with applied muntins. The recessed porch, located in the northeastern bay of the northwest, main elevation, includes a brick knee wall, segmental arch openings, and a historic, varnished wood ceiling. The primary entrance to the residence is located in the northwest side bay of the entry volume and includes a replaced 6-light door. A single window lights the remaining bay, with a triple window and a window under the jerkinhead lighting the entry volume. The southwest, side elevation is lighted by a single window in the northwest bay and a double window in each of the remaining bays. The rear volume is accessed by a secondary door with a straight stair in the central bay and is lighted by a single window in the southeast bay and a double window in the northwest bay. The southeast, rear elevation is not visible from the public right-of-way. The northeast, side elevation is regularly fenestrated with a window in each bay.

This property is a contributing property in the historic district because it retains integrity and historic character-defining features such as its historic massing and fenestration patterns, historic brick exterior, and historic open front porch.
