## PROPERTY REPORT

**Property Name:** 52 Maplewood Avenue **Ownership:** Private  
**Address:** 52 MAPLEWOOD AVE **Apartment #:** **ZIP:** 08512

**Survey Name:** Cranbury Local Historic District Survey 2018

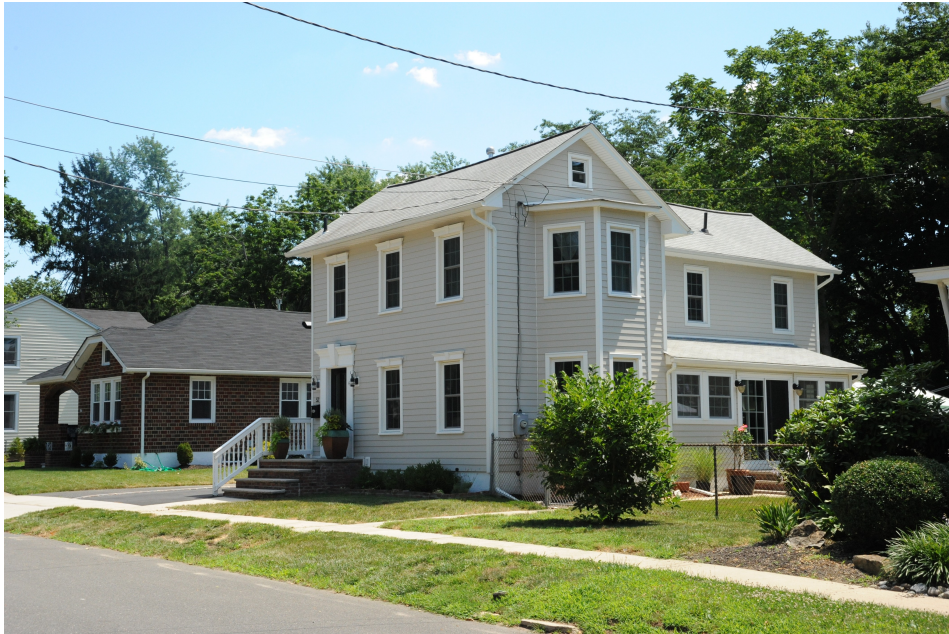
### Property Photo:

The 2-story, gable-roofed, L-plan, main block of this composite siding-clad, frame dwelling on a parged foundation is 3 bays wide and 5 bays deep. A 2-story, hip-roofed, 3-sided bay projects from the southwest elevation of the main volume. The main volume is backed on the southeast by a 2-story, gable-roofed, partial-width secondary volume offset to the northeast which is flanked on the southwest by a 1-story, shed-roofed, enclosed side porch. The roofs throughout are clad in asphalt shingle and the windows throughout have replacement sash with applied muntins. An exterior, vinyl siding-clad chimney projects from the central bay of the northeast elevation of the southeast volume. The primary entrance, located in the northeast bay of the northwest, main elevation, is accessed by a straight brick and concrete stair with a simple rail and turned balusters and includes a replaced door with an added door surround with an exaggerated keystone. Each of the remaining bays on both floors is lighted by a single window with added, keystone entablatures. The southwest, side elevation is lighted by 3 windows on each floor of the projecting bay with a small sash window under the gable eaves. The rear volume includes a secondary sliding door in the central bay flanked by double windows, with 2 single windows on the second floor. The southeast, rear elevation is not visible from the public right-of-way. The northeast, side elevation is lighted by a small stair window in the northwest block, with a small window under the gable eaves. The rear block is lighted by 1 window on the first floor and 2 windows on the second floor.

This property is a non-contributing property in the historic district by virtue of the building's loss of integrity from the loss of its historic porch, its historic cladding, and its historic wood windows.
