PROPERTY REPORT

Property Name: 50 Maplewood Avenue **Ownership:** Private
Address: 50 MAPLEWOOD AVE **Apartment #:** **ZIP:** 08512

Survey Name: Cranbury Local Historic District Survey 2018

Organization: Paulus, Sokolowski & Sartor

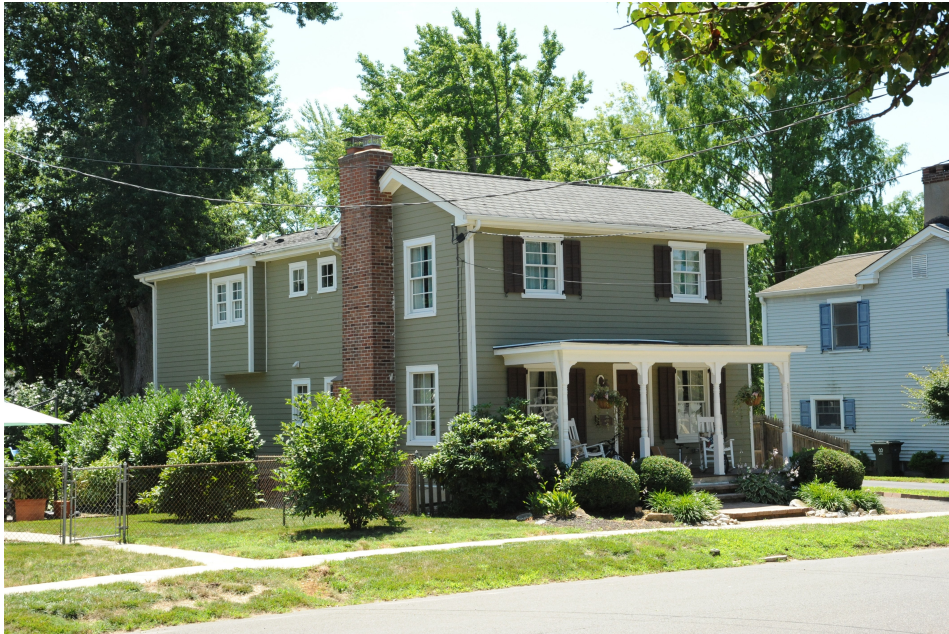
Property Photo:

PS&S recommends that the residence at 50 Maplewood Avenue, constructed between 1850 and 1876 and substantially altered, is a non-contributing property in the Cranbury Historic District.

The 2-story, gable-roofed, rectangular plan, main block of this composite siding-clad, frame dwelling on a parged foundation is 3-bays wide and 1 bay deep and is fronted on the northwest by a 1-story, nearly full-width, composite-roofed porch and backed by a 2-story, gable-roofed, full-width secondary volume. A projecting oriel is in the central bay of the second floor of the rear volume. The roofs are predominantly clad in asphalt shingle and the windows throughout have double-hung replacement sash. A substantial exterior brick chimney projects from the northeast elevation of the main block. The front porch includes replacement turned posts and added decorative brackets. The primary entrance to the residence is located in the central bay, with a window in each of the remaining bays of the first floor and in the outer bays of the second floor. The southwest, side elevation is lighted by a window on each floor of the main block with asymmetrical fenestration in the rear volume. The southeast, rear elevation is not visible from the public right-of-way. The northeast, side elevation is lighted by a window on each floor of the main block, with a single window on the first floor of the rear volume and 2 small fixed windows on the second floor. A double window lights the side oriel.

This property is a non-contributing property in the historic district because of the extent of replacement of exterior materials, and the visibility of the addition from the public right-of-way.
