## PROPERTY REPORT

**Property Name:** Ander Van Kirk House  
**Address:** 5 S MAIN ST

**Survey Name:** Cranbury Local Historic District Survey 2018

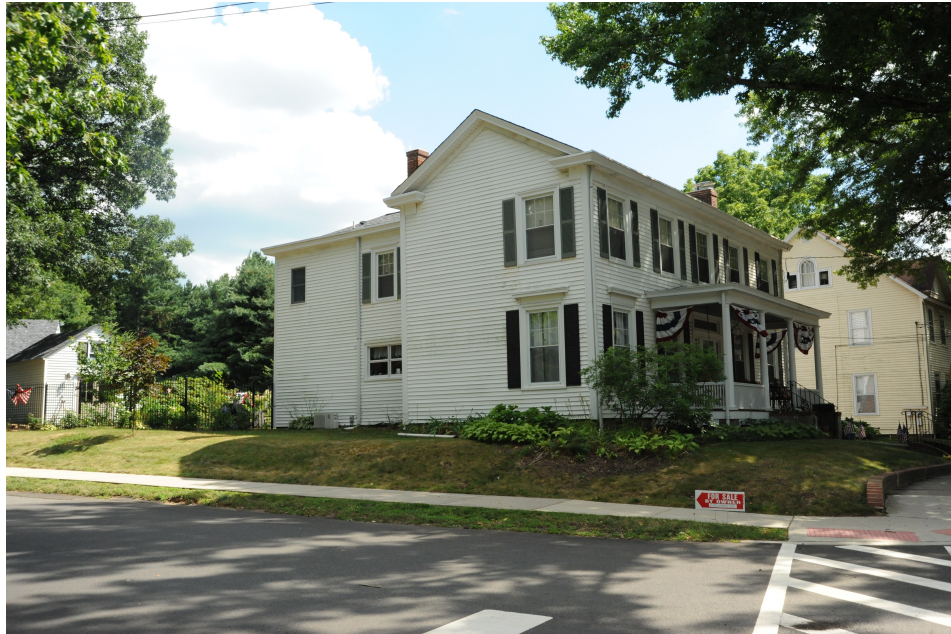
### Property Photo:

The 2-story, side gable-roofed, rectangular-plan main block of this aluminum siding-clad, frame dwelling on a parged foundation is 5 bays wide and 2 bays deep and is fronted on the northwest elevation by a 1-story, composite-roofed, 3-bay wide, centered porch and backed on the southeast elevation by a 2-story, gable-roofed secondary volume offset to the southwest and a 2-story, composite-roofed volume offset to the northeast. The southwest rear volume is backed by a 1-story, shed-roofed, enclosed porch. A 2-story, 3-sided window bay projects from the southwest elevation of the gable-roofed rear volume. The roofs are predominantly clad in asphalt shingle with eave returns at the gable-ends and the windows predominantly have 6/1 replacement sash with applied shutters. An exterior brick chimney projects from the southwest elevation of the main block, and a second exterior brick chimney projects from the northwest bay of the northeast elevation of the composite-roofed rear volume. The front porch on the northwest, main elevation includes replaced Tuscan columns and a replaced rail with square-section balusters. The primary entrance is located in the central bay and includes a historic door with a large, single light and historic single light side lights and transom. The remaining bays of both floors are regularly fenestrated, with a decorative entablature over the windows of the first floor. The southwest elevation of the main volume is lighted by 2 windows flanking the chimney on the first floor

and a single window lighting the west bay of the second floor. The 2-story window bay, which includes a projecting eave at the second floor, is lighted by a 3 windows on each floor. The southeast, rear elevation is only partially visible from the public right-of-way and is asymmetrically fenestrated with a secondary entrance in the south bay of the composite-roofed volume. The northeast, side elevation is lighted in the rear volume by 2 windows on the second floor and a smaller double window on the first floor. The main volume is lighted by a single window on each floor of the northwest bay.
