PROPERTY REPORT

Property Name: 29 South Main Street
Address: 29 S MAIN ST

Survey Name: Cranbury Local Historic District Survey 2018

Organization: Paulus, Sokolowski & Sartor

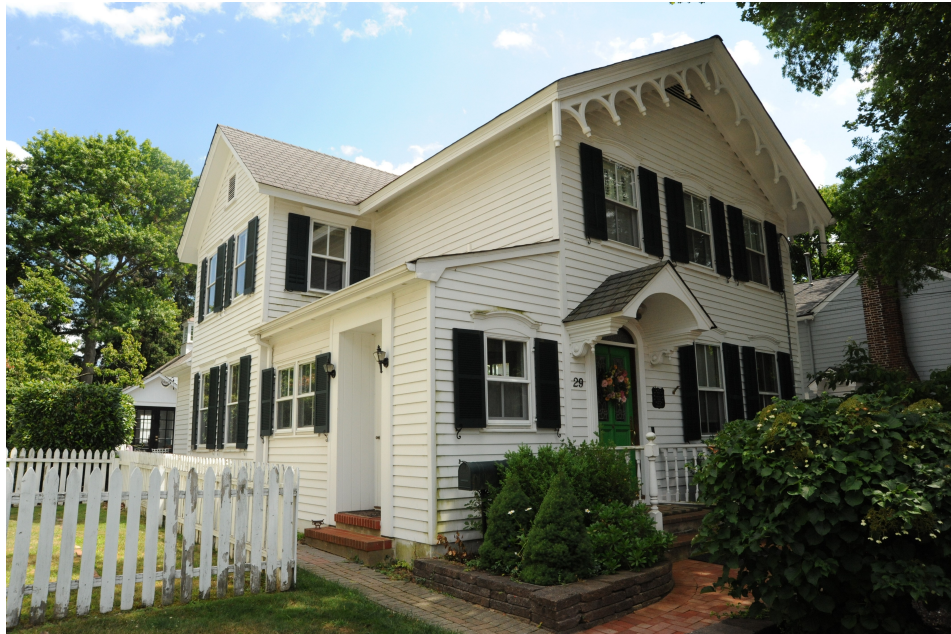
Property Photo:

The 2-story, gable-roofed, L-plan main block of this clapboard-clad dwelling on a parged stone foundation is 3 bays wide and 3 bays deep and is backed on the southeast by a 2-story, cross-gable-roofed rear volume that projects beyond the northwest elevation of the main volume. A 1-story, hip-roofed porch, added in 2016, backs the rear volume. A 1-story, shed-roofed, enclosed porch volume flanks the northeast side of the main volume. An added gabled door hood with a segmental arch opening and pendant brackets is located in the northeast bay of the northwest, main elevation. The roofs are predominantly clad in asphalt shingle and the windows predominantly have 2/2 replacement wood sash. An interior brick chimney projects from the central bay of the southwest roof slope. The primary entrance, located in the northeast bay of the northwest, main elevation, includes a 2-light, leaded glass, replaced door with replaced, segmental arch, leaded glass transom and a replaced rail with replaced newels. The remaining bays of both floors are regularly fenestrated and include historic shutters and eyebrow arch entablatures. A single window lights the enclosed porch volume. The southwest, side elevation is regularly fenestrated in both the main and rear volumes. The northeast, side elevation is regularly fenestrated and includes a secondary, recessed opening in the northwest bay of the enclosed porch. The southeast, rear elevation is not visible from the public right-of-way. The 1-story, gable-roofed, frame outbuilding, located to the southeast of the residence, is accessed on the northwest and southeast elevations

by added French doors and on the southwest elevation by a historic, 6-light door with a flanking historic window. The 1 ½-story, gable-roofed, frame garage, located to the southeast of the outbuilding, is 2-bays wide and is lighted by 6/6 sash windows. A cupola with fixed 9-light windows is in the central bay of the gable ridge.

The residence at 29 S. Main Street is a contributing property in the Cranbury Historic District because it retains integrity and historic, character-defining features such as the historic wood shutters, historic bargeboard, historic clapboard, and historic secondary building.
