## PROPERTY REPORT

**Property Name:** 33 South Main Street  
**Address:** 33 S MAIN ST

**Survey Name:** Cranbury Local Historic District Survey 2018

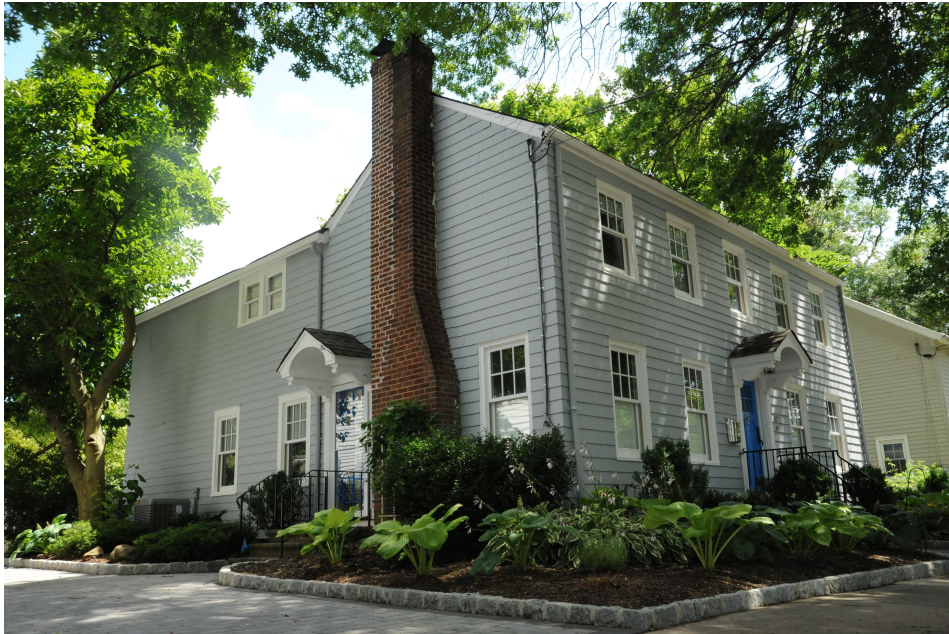
### Property Photo:

The 2-story, gable-roofed, rectangular-plan main block of this painted wood shingle-clad, frame dwelling on a stone and parged foundation is 5 bays wide and 2 bays deep and is backed on the southeast by a 2-story, gable-roofed, partial-width secondary volume. The rear volume is in turn flanked by a 1-story, shed-roofed, enclosed porch volume on the southwest elevation. Gable-roofed, segmental arch door-hoods on scroll brackets in located on both the northwest, main and northeast, side elevation. The roofs are predominantly clad in asphalt shingle and the windows predominantly have 6/1 replacement wood sash. An exterior brick chimney projects from the center of the northeast elevation of the main volume. The primary entrance to the residence, located in the central bay of the northwest elevation, is accessed by a straight brick stair with wrought iron rail and includes a historic 8-light door with extended recessed panels and a historic, fluted pilaster door surround that joins the door hood. The remaining bays are regularly fenestrated on both floors. The southwest, side elevation is lighted in the main block by a triple window on the first floor and a double window on the second floor. The enclosed rear porch is lighted by 2 fixed, 8-light windows and includes a secondary door in the northwest bay. The second floor of the rear volume is lighted by 2 single windows. The northeast, side elevation includes an 18-light door in the southeast bay with a door surround that matches that of the primary entrance, though the brackets of the door hood are shaped with a simpler profile. A single window lights the northwest bay of

the main block. The rear volume is lighted by 2 single windows on the first floor and a smaller, double, 1/1 window on the second floor. The southeast, side elevation is not visible from the public right-of-way. The 1-story, gable-roofed, frame garage located to the southeast of the residence, is accessed by a garage door on the northeast elevation and is lighted by a historic window on the northwest elevation.
