PROPERTY REPORT

Property Name: 3 Station Road
Address: 3 STATION RD
Ownership: Private
Apartment #: **ZIP:** 08512

PS&S recommends that 3 Station Road, built ca. 1850 or earlier, is a contributing property in the Cranbury Historic District.

Survey Name: Cranbury Local Historic District Survey 2018

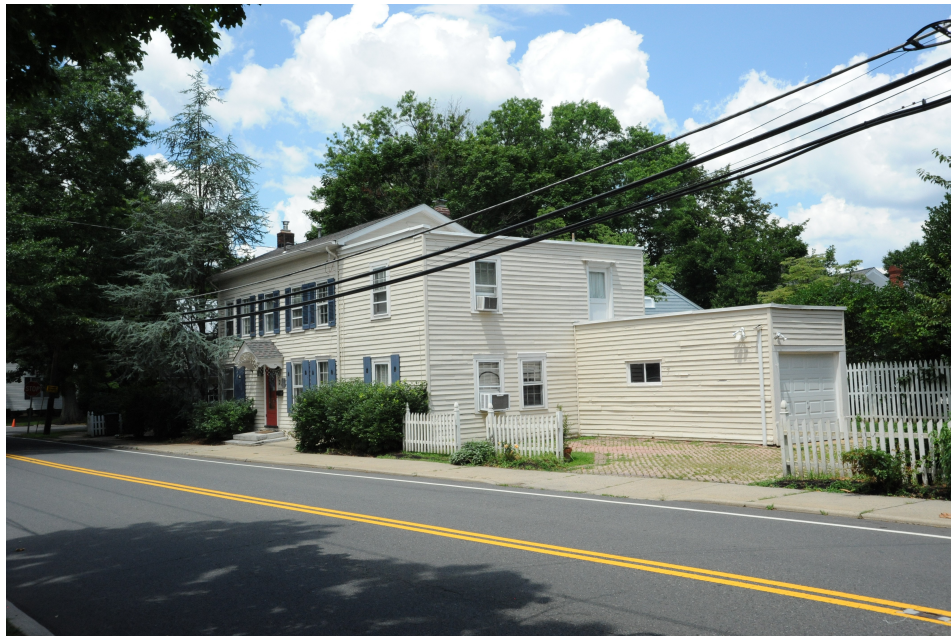
Property Photo:

The 2-story, side gable-roofed, rectangular-plan main block of this clapboard-clad, frame dwelling on a stone foundation is 5 bays wide and 2 bays deep and is backed on the north by a 2-story, flat-roofed addition that wraps around the full depth of the east side. The west bay of the main block is backed by a 1-story, shed-roofed el. A 1-story, flat-roofed garage flanks the east side of the rear volume and is offset to the north. The roof of the main block is clad in asphalt shingle and the windows of the main block predominantly have 6/6, historic wood sash. An exterior brick chimney is located in the center of the west elevation. The primary entrance to the residence, located in the central bay of the south, main elevation, includes a historic, replacement single-light storm door, a historic replacement door with a single, fixed light over recessed panels, and a historic, added, gabled door hood with a segmental arch opening and scrolled brackets. The remaining bays are regularly fenestrated, with a leaded glass window in the center bay of the second floor and a 1/1 window in the west bay of the first floor. The windows of the first floor have historic replacement paneled shutters with decorative cut outs and the windows of the second floor have historic, louvered shutters. The addition is lighted by a 3/1 historic wood sash window on the first floor and a 6/1, wood sash window on the second floor. A 2-light window lights the garage. The east, side elevation is lighted by 2 6/6 windows on the first floor in the addition and a single, 3/1 window on the second floor. A historic, single-light door provides access to the roof of the garage from the addition. The garage is accessed by a roll-up door on its east elevation. The west elevation is lighted by a window on each floor

of the south bay and 2 single-light fixed windows under the gable. The north, rear elevation is not visible from the public right-of-way. A 1-story, gable-roofed shed is located to the northeast of the residence.

The residence at 3 Station Road is a contributing property in the Cranbury Historic District because it retains integrity and character-defining historic features such as its historic massing and fenestration patterns of its main volume windows, historic shutters, historic wood windows in multiple locations, historic added door hood, and historic chimneys.
