## PROPERTY REPORT

**Property Name:** 11 Station Road

**Address:** 11 STATION RD

**Survey Name:** Cranbury Local Historic District Survey 2018

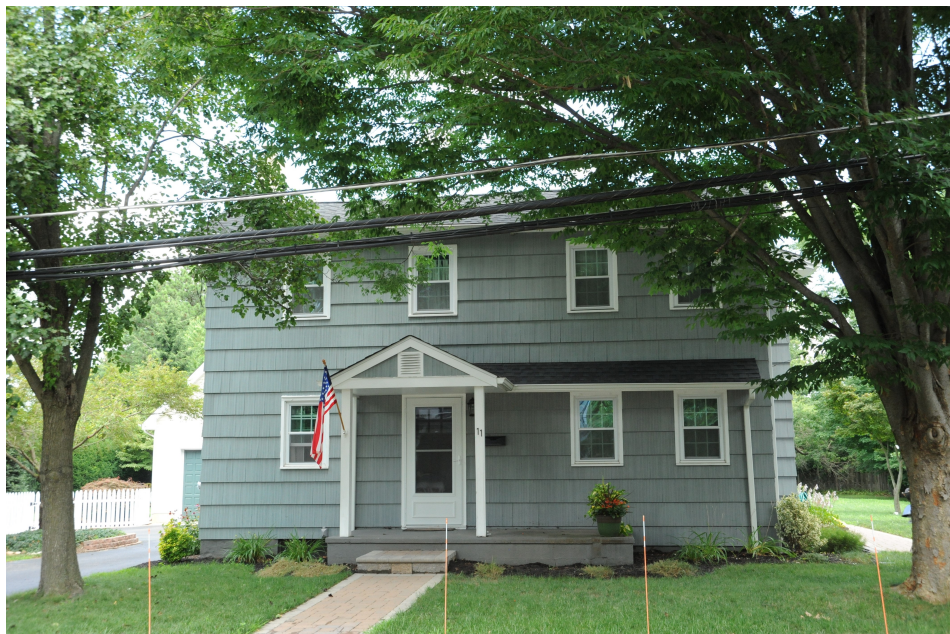
**Property Photo:**

The 2-story, side gable-roofed, rectangular-plan main block of this asbestos shingle-clad, frame residence on a parged foundation is 4 bays wide and 2 bay deep and is fronted on the south by a central, gable-roofed, 1-bay porch and backed on the north by a 1 1/2-story, partial-width, shed-roofed rear volume that is offset to the west. A 2-story, gable-roofed addition that projects slightly beyond the east elevation backs the main volume east of the shed-roofed volume. An added pent eave divides the first and second floors in the east bays of the south elevation. An interior, ridge, stuccoed chimney is located near the west end of the main block. The visible roofs are clad in asphalt shingle and the windows throughout have double-hung, replacement vinyl sash. The front porch, on a poured-in-place concrete deck, includes square-plan posts and provides access to the primary entrance, which includes a 6-light replacement door. The remaining bays are regularly fenestrated on both floors. The east, side elevation is lighted by a central window on each floor of the main block, with a replacement attic vent under the gable end. A secondary door flanked by a small sliding window provides access to the added volume. The west, side elevation is lighted in the main block by a single, offset window on each floor and in the rear volume by a paired window. Small vents are located under the gable end of the main block, with an additional vent near the peak of the rear volume.

Historic maps indicate that Station Road was developed beginning in the first half of the 19th century. The 1980 National Register of Historic Places Nomination for the Cranbury Historic District inventoried this residence as having been constructed in the early part of the 20th century. However, design features such as the side-gable roof, attic vents, and narrow main block suggest that the dwelling was constructed in the 3rd quarter of the 19th century. The 1876 Everts and Stewart map documents a residence on the lot as the property of "N. Rue." The residence is documented on the 1916 Sanborn map as a 2-story, rectangular-plan dwelling with a 1-story, partial-width, central front porch, and a 2-story rear, partial-width rear volume backed by a 1-story porch. Historic aerial photographs indicate that a 2-story rear volume was added during the 1950s. Visual evidence suggests multiple other changes in this project, including the installation of the current front porch and pent eave, and the cladding of the exterior in asbestos shingle. The 1974 photographic inventory of Cranbury historic buildings in the collection of the Cranbury Historical and Preservation Society shows the residence with asbestos shingle cladding, 2/2 window sash with horizontal muntins, a 2-light replacement door, a pent eave in the east bay of the south elevation, and a bank of 4 casement windows in the rear volume. Visual evidence suggests that the windows have been replaced within the last ten years.

11 Station Road is a non-contributing property in the Cranbury Historic District because of it has lost integrity of design, workmanship, and materials from multiple alterations after the period of significance, that include the loss of historic windows and other exterior materials, changes in fenestration patterns, and the addition of a large, highly visible rear volume that has distorted the historic massing of the building.
