PROPERTY REPORT

Property Name: 7-9 South Main Street
Address: 9 S MAIN ST

Survey Name: Cranbury Local Historic District Survey 2018

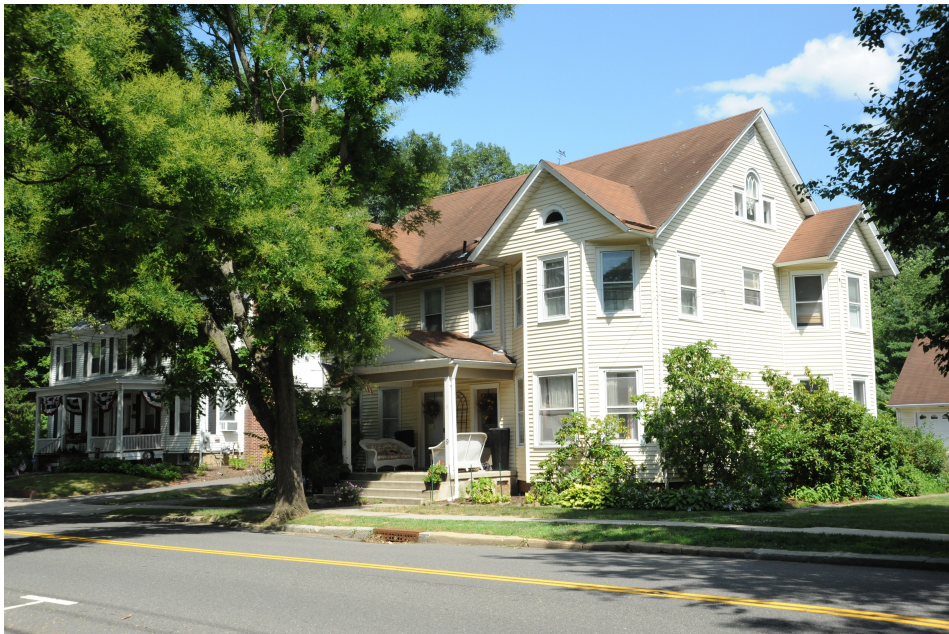
Property Photo:

PS&S recommends that 7-9 S. Main Street, which includes a historic former combination grocery store and residence built ca. 1910, now a double residence, is a contributing property in the Cranbury Historic District. The altered garage and later shed do not contributed to the property.

The 2 ½-story, side gable-roofed, rectangular-plan main block of this vinyl siding-clad, frame, double dwelling on a parged foundation is 7 bays wide and 4 bays deep and is fronted on the northwest elevation by a 1-story, partial-width, centered, gable-roofed porch and backed on the southeast elevation by a 1-story, shed-roofed rear el. A 2-story, 3-sided bay with a projecting gable roof is located in the southwest bay of the main elevation, with a wall gable in the northeast bay. A gable-roofed, 3-sided bay is located in the southeast bay of the southwest, side elevation. The roofs are predominantly clad in asphalt shingle and the windows predominantly have 1/1, historic wood sash. The front porch, includes square section posts and is accessed by a straight stair. The primary entrances to the residences, accessed by the porch, both retain historic doors with large single lights. The remaining bays of both floors are regularly fenestrated, with half-round windows in the wall-gable and projecting bay gable. The southwest, side elevation is lighted on the first and second floors by 3 windows in the projecting bay, with a single window in the northwest bay and a smaller window in the central bay. The southeast, rear elevation is not visible from the public right-of-way. The northeast, side elevation is lighted on the first floor by a double window in the east bay, a single window in the northwest bay, and 3 windows on the second floor. A Serliana (Palladian) window with a lancet-arched central

sash lights the third floor of both the northeast and southwest side elevations.

The residence at 7-9 S. Main Street is a contributing property to the Cranbury Historic District because it retains integrity and historic, character-defining features such as its historic massing, historic doors, and historic Serliana windows. The garage, which has been extensively renovated and does not retain any historic materials visible from the public right-of-way, does not contribute to the Cranbury Historic District.
