PROPERTY REPORT

Property Name: 7-9 South Main Street
Address: 9 S MAIN ST

Survey Name: Cranbury Local Historic District Survey 2018

Organization: Paulus, Sokolowski & Sartor

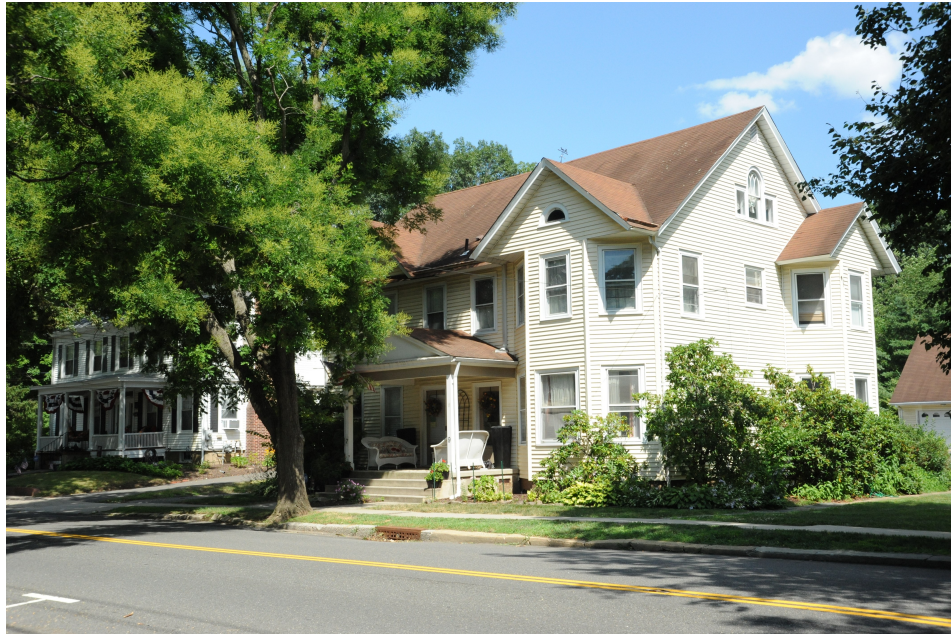
Property Photo:

The 2 ½-story, side gable-roofed, rectangular-plan main block of this vinyl siding-clad, frame, double dwelling on a parged foundation is 7 bays wide and 4 bays deep and is fronted on the northwest elevation by a 1-story, partial-width, centered, gable-roofed porch and backed on the southeast elevation by a 1-story, shed-roofed rear el. A 2-story, 3-sided bay with a projecting gable roof is located in the southwest bay of the main elevation, with a wall gable in the northeast bay. A gable-roofed, 3-sided bay is located in the southeast bay of the southwest, side elevation. The roofs are predominantly clad in asphalt shingle and the windows predominantly have 1/1, historic wood sash. The front porch, includes square section posts and is accessed by a straight stair. The primary entrances to the residences, accessed by the porch, both retain historic doors with large single lights. The remaining bays of both floors are regularly fenestrated, with half-round windows in the wall-gable and projecting bay gable. The southwest, side elevation is lighted on the first and second floors by 3 windows in the projecting bay, with a single window in the northwest bay and a smaller window in the central bay. The southeast, rear elevation is not visible from the public right-of-way. The northeast, side elevation is lighted on the first floor by a double window in the east bay, a single window in the northwest bay, and 3 windows on the second floor. A Serliana (Palladian) window with a lancet-arched central

sash lights the third floor of both the northeast and southwest side elevations.

The residence at 7-9 S. Main Street is a contributing property to the Cranbury Historic District because it retains integrity and historic, character-defining features such as its historic massing, historic doors, and historic Serliana windows. The garage, which has been extensively renovated and does not retain any historic materials visible from the public right-of-way, does not contribute to the Cranbury Historic District.
