PROPERTY REPORT

Property Name: 11 South Main Street
Address: 11 S MAIN ST

Survey Name: Cranbury Local Historic District Survey 2018

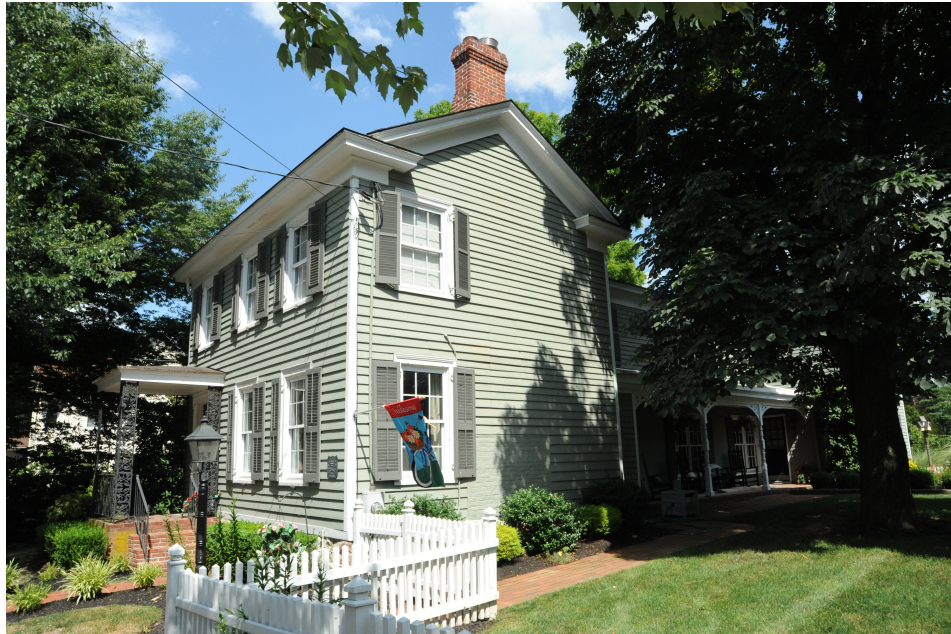
Property Photo:

The 2-story, side gable-roofed, rectangular-plan main block of this clapboard-clad, frame dwelling on a stone foundation is 3 bays wide and 2 bays deep and is fronted on the northwest elevation by a 1-story, hip-roofed, partial-width porch offset to the northeast, and backed on the southeast elevation by a 2-story, gable-roofed volume. The rear volume is in turn backed by a 2-story, cross gable-roofed addition. A 1-story, shed-roofed porch flanks the southwest elevation of the rear volume, and a 1-story, composite-roofed, 3-sided window bay is on the northwest bay of the northeast elevation of the rear volume. A 1-story, shed-roofed, enclosed porch backs the northeast bay of the rear volume. The roofs are predominantly clad in asphalt shingle with eave returns at the gable-ends and the windows predominantly have 6/6 replacement vinyl sash with applied muntins and historic louvered wood shutters. A substantial, replaced, interior brick chimney projects from the west bay of the gable ridge. A second substantial, exterior brick chimney projects from the northeast elevation of the rear volume. The primary entrance with historic replacement door and historic door surround is located in the northeast bay of the northwest elevation and is accessed by the front porch, which includes a brick stair, cast iron posts, and a wrought-iron rail. The remaining bays of both floors are regularly fenestrated. The southwest, side elevation is lighted in the main volume by a window on each floor of the northwest bay. The painted brick chimney base is exposed in the lower portion of the first floor of the central bay. The rear volume, only partially visible from the public right-of-way, is lighted by double windows on the first floor and single windows on the second floor and includes a secondary

entrance. The rear porch includes historic turned posts and historic wood brackets. The rear volume is not visible from the public right-of-way. The northeast, side elevation is lighted 2 windows on the first floor of the main volume, 3 windows in the projecting bay of the rear volume, and 2 windows on the second floor of the rear volume.

The residence at 11 S. Main Street is a contributing property in the Cranbury Historic District because it retains integrity and historic, character-defining features such as its historic massing of the main volume, historic wood shutters, historic rear porch posts, and historic eave returns.
