# PROPERTY REPORT

**Property Name:** 13 South Main Street      **Ownership:** Private  
**Address:** 13 S MAIN ST      **Apartment #:**      **ZIP:** 08512

<b>Survey Name:</b> Cranbury Local Historic District Survey 2018	<b>Property ID:</b> <span style="border: 1px solid black; padding: 2px;">-711156334</span>	Page 1
<b>Principal Investigator:</b> Emily Cooperman	<input type="checkbox"/> (Primary Contact)	
<b>Organization:</b> Paulus, Sokolowski & Sartor

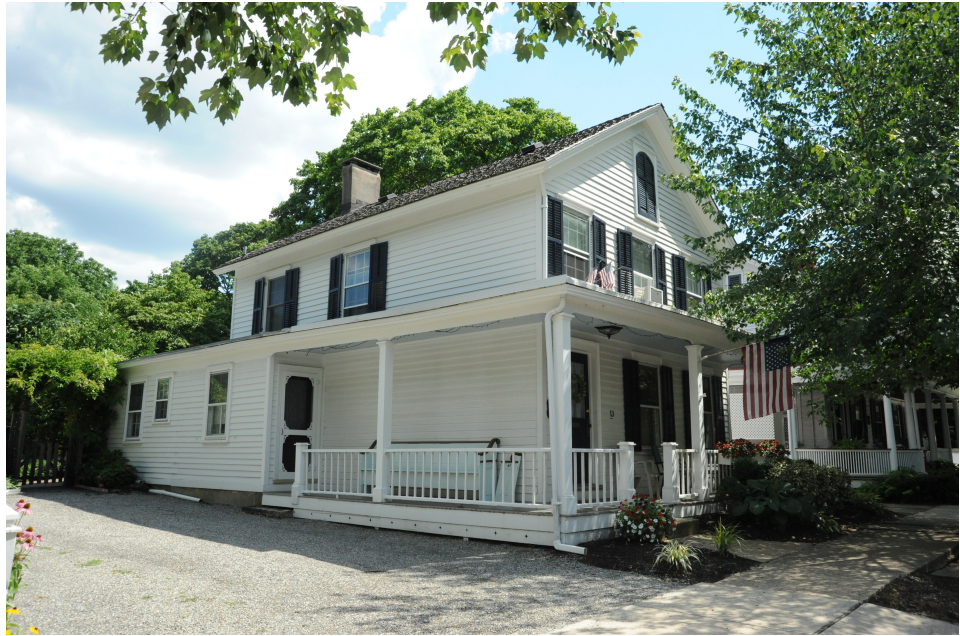
**Property Photo:**

The 2 ½-story, gable-roofed, rectangular-plan main block of this clapboard-clad, frame dwelling on a parged foundation is 3 bays wide and 3 bays deep and is fronted on the northwest by a 1-story, composite-roofed porch that wraps around the northwest bays of the northeast elevation and is backed on the southeast by a 2-story, composite-roofed volume. A 1-story, composite-roofed rear volume is on the east corner of the residence. The main roof is clad in wood shingle and the windows predominantly have 1/1 replacement wood sash on the first floor and 6/6 historic wood sash on the second floor, all with historic shutters. A stuccoed interior chimney projects from the southeast bay of the gable ridge. The porch includes historic square-plan posts and a historic rail with square-plan balusters. The primary entrance is located in the northeast bay of the northwest, main elevation and includes a historic door with a large single light. A secondary door, accessed by the porch on the northeast side, provides access to the 1-story rear volume. The remaining bays of the northwest elevation are regularly fenestrated on both floors. A shuttered, segmental-arch window lights the third floor. The southwest, side elevation is lighted by 3 windows on the second floor and a single window in the northwest bay and a double window of the southeast bay of the first floor. The rear volume is lighted by double, 4-light, awning window on the first floor and a single window on the second floor. The northeast, side elevation is lighted by 3 windows in the 1-story volume and a window in the southeast and central bay of the second floor. The southeast, rear elevation is not visible from the public right-of-way.

13 S. Main Street is a contributing property in the Cranbury Historic District because it retains integrity and historic character-defining features, such as its historic massing, historic clapboard, historic window sash, historic front door, and historic porch posts.
