## PROPERTY REPORT

**Property Name:** 13 South Main Street  
**Address:** 13 S MAIN ST

PS&S recommends that 13 S. Main Street, constructed circa 1875-80, is a contributing property in the Cranbury Historic District.

**Survey Name:** Cranbury Local Historic District Survey 2018

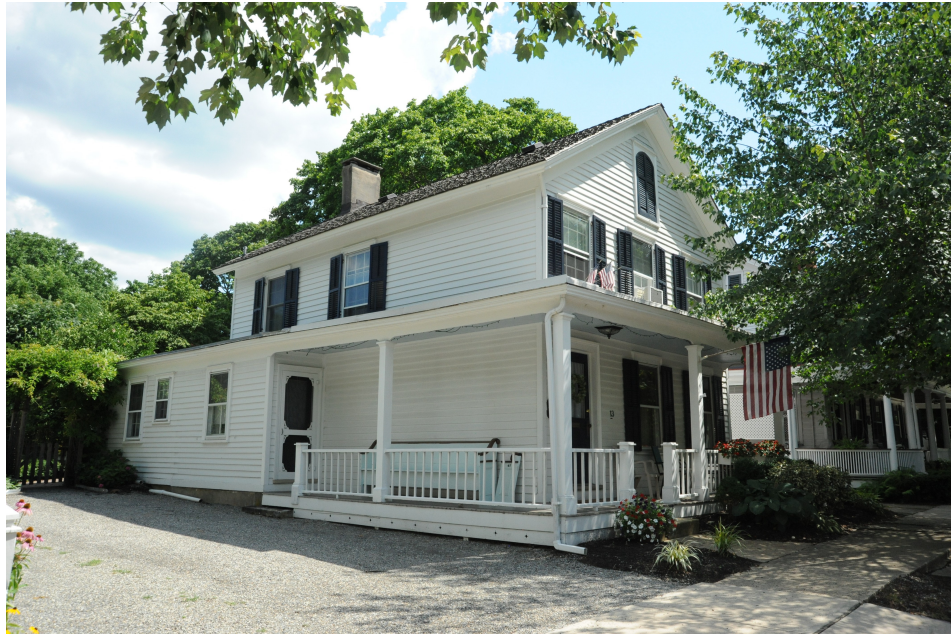
### Property Photo:

The 2 1/2-story, gable-roofed, rectangular-plan main block of this clapboard-clad, frame dwelling on a parged foundation is 3 bays wide and 3 bays deep and is fronted on the northwest by a 1-story, composite-roofed porch that wraps around the northwest bays of the northeast elevation and is backed on the southeast by a 2-story, composite-roofed volume. A 1-story, composite-roofed rear volume is on the east corner of the residence. The main roof is clad in wood shingle and the windows predominantly have 1/1 replacement wood sash on the first floor and 6/6 historic wood sash on the second floor, all with historic shutters. A stuccoed interior chimney projects from the southeast bay of the gable ridge. The porch includes historic square-plan posts and a historic rail with square-plan balusters. The primary entrance is located in the northeast bay of the northwest, main elevation and includes a historic door with a large single light. A secondary door, accessed by the porch on the northeast side, provides access to the 1-story rear volume. The remaining bays of the northwest elevation are regularly fenestrated on both floors. A shuttered, segmental-arch window lights the third floor. The southwest, side elevation is lighted by 3 windows on the second floor and a single window in the northwest bay and a double window of the southeast bay of the first floor. The rear volume is lighted by double, 4-light, awning window on the first floor and a single window on the second floor. The northeast, side elevation is lighted by 3 windows in the 1-story volume and a window in the southeast and central bay of the second floor. The southeast, rear elevation is not visible from the public right-of-way.

13 S. Main Street is a contributing property in the Cranbury Historic District because it retains integrity and historic character-defining features, such as its historic massing, historic clapboard, historic window sash, historic front door, and historic porch posts.
