## PROPERTY REPORT

**Property Name:** Elizabeth Johnson House **Ownership:** Private  
**Address:** 15-17 S MAIN ST **Apartment #:** **ZIP:** 08512

**Survey Name:** Cranbury Local Historic District Survey 2018

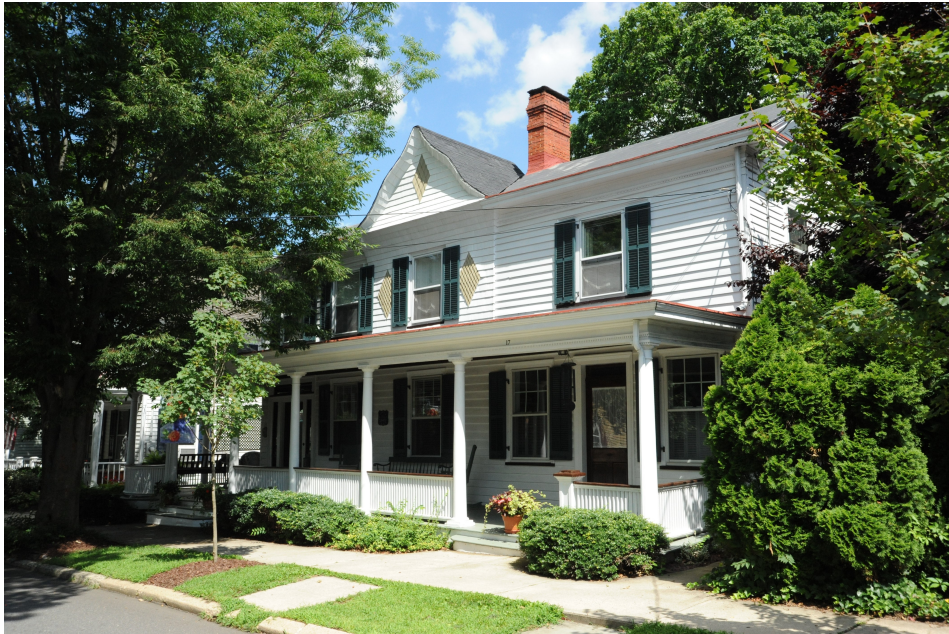
### Property Photo:

The 2-story, gable-roofed, L-plan main block of this clapboard-clad, frame, double dwelling on a parged foundation is 6 bays wide and 2 bays deep and is fronted on the northwest by a 1-story, complexly-roofed, partial wrap-around porch and backed by a 2-story, gable-roofed, partial-width secondary volume offset to the southwest and 2-story, composite-roofed volume offset to the northeast that projects beyond the northeast elevation of the main volume. A 1-story, shed-roofed addition projects from the southwest elevation of the rear volume. A scalloped, gable-roofed dormer, located in the central bay of the northwest elevation, projects above the roofline of the main volume. The roofs are clad in multiple materials and include eave returns. The windows predominantly have 1/1 sash with shutters. A dentiled frieze runs along the northwest, main elevation, and is interrupted in the central bay by sloped shingles that descend from the dormer to the porch roof. An interior brick chimney with a flared cap projects from the central bay of the gable-ridge to the southwest of the dormer. The full-width front porch wraps around the north corner of the residence and joins flush with the projecting rear volume. The porch features a rounded, conical-roofed projection at the corner and includes historic columns with dentiled capitals, a historic rail with square-plan balusters, and a historic dentiled frieze. The porch is accessed on the northwest elevation by a stair in both the northeast and southwest bays and on the northeast elevation in the southeast bay. The primary entrance to the residence, located in the northeast bay of

the northwest elevation, includes a historic door with an oval light and historic door surround. A secondary historic single-light door is located in the southeast bay, flanked on each side by a 6/1 window. 2 6/1 windows light the remaining bays of the first floor. A third, historic single-light door is located on the northeast elevation of the rear volume. The second floor is lighted by 4 1/1 windows. A decorative diamond shingle pattern flanks the window in the central bay and is repeated in the scalloped dormer. The southwest, side elevation and southeast, rear elevations are not visible from the public right-of-way. The northeast, side elevation is lighted by 2 windows in the rear volume, a window on each floor of the northwest bay of the main volume, and a fixed, single-light, diamond window on the second floor of the southeast bay.

The residence is a contributing property to the historic district because integrity and historic, character-defining features such as its historic massing, historic wood doors, historic wood shutters, historic porch columns, porch rails, porch balusters, and porch dentils, historic clapboard and shingle siding, and historic scalloped dormer. The storage building retains its historic wood clapboard and historic doors, windows, and shutters.
