PROPER	TY REPORT			Property ID:	2121572383	
Property Name:	Cranbury Inn			Owners	ship: Private	
Address:	21 S MAIN ST	Apartment #: ZIP: 08512			ZIP: 08512	
PROPERTY LOC	ATION(S):					
County:	Municipality:	Local Place Name:	USGS Quad:	Block:	Lot:	
MIDDLESEX	Cranbury township			35	7.01

Survey Name:	Cranbury Local Historic District Survey 2018		Property ID:	Page 1
Principal Investigator:	Emily Cooperman	(Primary Contact)	2121572383	
Organization:	Paulus, Sokolowski & Sartor

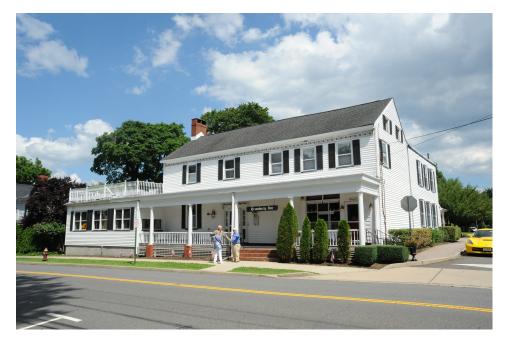
Property Photo:

The 2 ½-story, gable-roofed, rectangular-plan main block of this aluminum siding-clad, frame historic hotel on a parged foundation is 6 bays wide and 2 bays deep and is fronted on the northwest, main elevation by a 1-story, full-width, composite-roofed porch and backed on the southeast elevation by a 2-story, composite-roofed volume to the southwest and a 2-story, gable-roofed volume to the northeast. These are in turn backed by multiple additions: a 1-story hyphen links to a 1 ½-story, gable-roofed volume with extended gabled dormers, which is backed in turn by a large, 2-story, gable-roofed volume. A 1-story, composite-roofed side addition flanks the northeast elevation. The roofs are predominantly clad in asphalt shingle with a historic punch and gouge frieze on the northwest elevation of the main volume. The windows of the main volume predominantly have 1/1 replacement sash with applied shutters. An interior brick chimney projects from the northeast slope of the gable-roofed, dormered rear volume. The front porch, accessed by a brick stair with wrought iron rails in the southwest, central bay of the northwest elevation and the single bay of the southwest elevation, includes replaced columns on brick piers, a historic rail, and replaced balusters. A single historic pilaster is located on the southwest corner of the hotel. The primary entrance is located in the northeast, central bay and includes a historic door with historic 3-light sidelights, fluted pilasters, and a historic dentiled cornice. A secondary entrance, labeled the Package

Store, is located in the southwest bay and is flanked to the northeast by a large, 9-light display window. A single window lights the northeast bay. The second floor is asymmetrically fenestrated by 5 single windows. The side volume, which projects further northwest than the main volume, is lighted by 3 double windows on the northwest elevation and a single double window on the southwest elevation. The southwest, side elevation of the main volume is lighted by a single window on the second floor and 2 smaller windows with historic window frames on the third floor. The composite-roofed rear volume is lighted by 3 windows on each floor. A secondary 15-light entrance is located in the southeast elevation hyphen. A single window lights an extended dormer in this volume. The gable-roofed, dormered volume includes a recessed porch with columns on stone piers and is accessed by 2 sets of double 15-light doors flanked by an 8/8 window, with 6/6 windows lighting the dormers. The 2-story rear volume includes a wall gable lighted by large multi-light fixed windows in the northeast bay and is regularly fenestrated with 6/6 windows on both floors of the remaining bays. The southeast, rear elevation of the volume is lighted on the second floor by a large, 3-sided, segmental arch, fixed window. The northeast, side elevation is not visible from the public right-of-way.

This property is a key-contributing property in the historic district because retains integrity and such key historic character-defining features as its historic massing and fenestration patterns, its open front porch, and historic doorway.
