## PROPERTY REPORT

**Property Name:** 25 South Main Street  
**Address:** 25 S MAIN ST

**Survey Name:** Cranbury Local Historic District Survey 2018

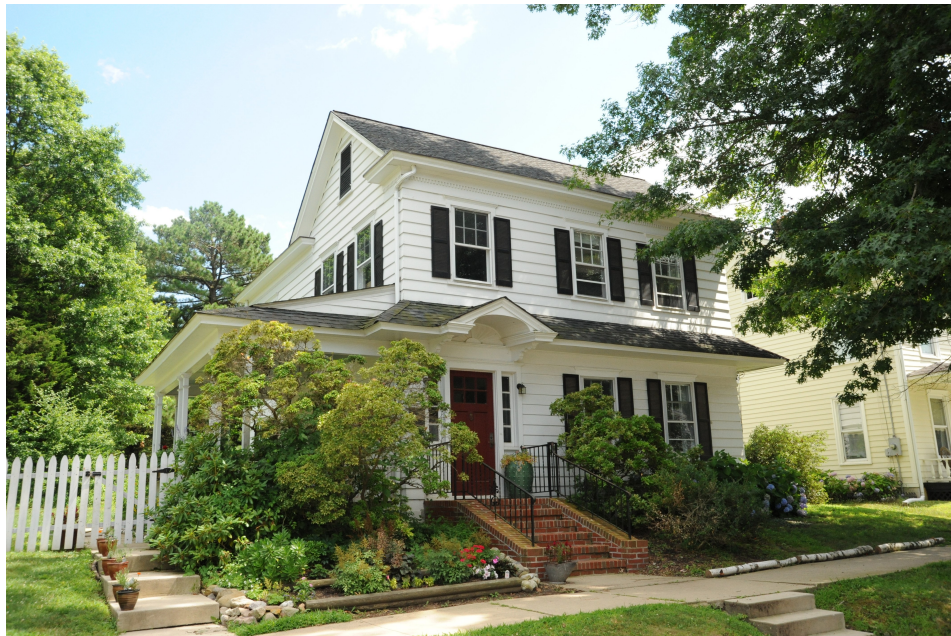
### Property Photo:

The 2-story, gable-roofed, rectangular-plan main block of this clapboard-clad, frame residence is 3 bays wide and 2 bays deep and is backed on the southeast elevation by a 2-story, full-width, cross gable-roofed volume. A 1-story, partial-length, shed-roofed porch is on the northeast, side elevation. A 2-story, rectangular-plan bay projects from the southeast end of the southwest elevation. The 2 floors of the main block are divided on all elevations by a pent eave. A gabled door hood on brackets is located in the northeast bay of the northwest elevation. A 1-story, shed-roofed volume projects from the southeast elevation. The roofs throughout are clad in asphalt shingle and the windows predominantly have 6/1 historic wood sash with applied shutters. The horizontal rooflines of both the main and rear blocks include a dentiled cornice. An interior brick chimney projects from the gable ridge of the rear volume. The primary entrance, located in the northeast bay of the northwest elevation, includes a historic 6-light door with extended recessed panels and 4-light sidelights over recessed panels. The door hood includes a basket-handle arch under the pediment and a paneled fan. The remaining bays of both floors are regularly fenestrated and include simple entablatures and applied shutters. The southwest, side elevation is lighted on both floors of the main volume by a double window, with a shuttered window on the first floor. The projecting bay is lighted by single windows on the northwest elevation and 2 single windows on both floors of the southwest elevation. The northeast, side elevation includes the shed-roofed

porch in the northwest bays, which includes square-plan, paired posts with cornice and capitals. A secondary entrance is located in the northwest bay. The remaining bays of the main and rear volumes are regularly fenestrated. A single, smaller, shuttered window is under the gable-end of both side elevations. The southeast, rear elevation is not visible from the public right-of-way.

25 S. Main is a contributing property in the Cranbury Historic District because it retains integrity and historic, character-defining features such as the historic door surround and door hood, dentiled cornice, historic porch posts, historic window sash, and historic clapboard siding.
