PROPERTY REPORT

Property Name: 27 South Main Street
Address: 27 S MAIN ST

Survey Name: Cranbury Local Historic District Survey 2018

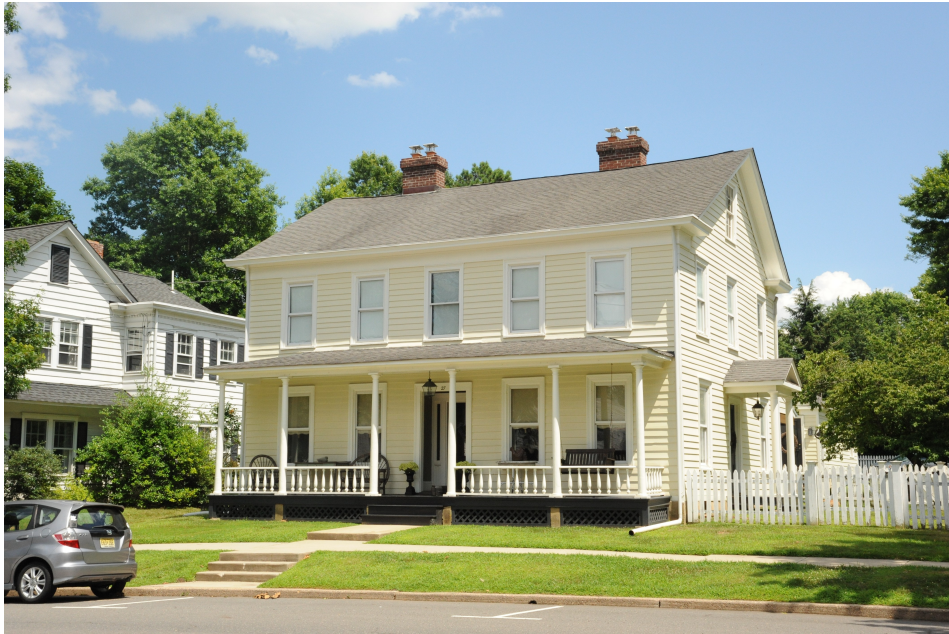
Property Photo:

The 2 1/2-story, gable-roofed, rectangular-plan main block of this clapboard-clad, frame dwelling on a parged foundation is 5-bays wide and 3-bays deep and is fronted on the northwest elevation by a 1-story, hip-roofed, full-width porch and backed on the southeast elevation by a 2-story, complexly-roofed, partial-width, altered rear volume. This is in turn backed by a 2-story, gable-roofed, 5-bay deep addition. A 1-story-gable-roofed garage, accessed on the southeast elevation, projects beyond the rear addition. A 1-story, shed-roofed, partial wrap-around porch projects from the southeast elevation of the main block. A 1-story, 1-bay, pedimented gable-roofed porch projects from the central bay of the southwest elevation. The roofs are predominantly clad in asphalt shingle and the windows of the main block predominantly have 1/1 replacement sash. Two interior brick chimneys project from the gable ridge of the main block. The front porch, accessed by a straight stair in the central bay, includes historic Tuscan columns and a historic rail with turned balusters. The recessed primary entrance to the residence, located in the central bay, includes a historic door with a large single light over a recessed panel. The historic door surround includes narrow single light sidelights and transom that appear to predate the door. The remaining bays of both floors are regularly fenestrated. The southwest, side elevation is regularly fenestrated and includes an added secondary entrance in the central bay. The pedimented porch includes added columns. The northeast, side elevation is lighted by a window in each floor of the outer

bays. A 6/6 sash window lights the third floor of both side elevations. The rear porch includes a simple square-plan post. The rear volume is only partially visible from the public right-of-way and is lighted by a bank of 6/1 windows on the first floor and regularly fenestrated by 6/6 sash on the second floor. A door provides access to the northwest elevation of the garage. The northeast, side elevations of the rear volumes are not visible from the public right-of-way.

27 S. Main Street is a non-contributing property in the Cranbury Historic District because of multiple campaigns of alteration that have removed historic material and altered historic massing after the period of significance.
